Fatigue Performance of Exfoliated E-8C Upper Wing Skin Material

**Center for Aircraft Structural Life Extension
Department of Engineering Mechanics**

October 2004

USAFA-TR-04-07

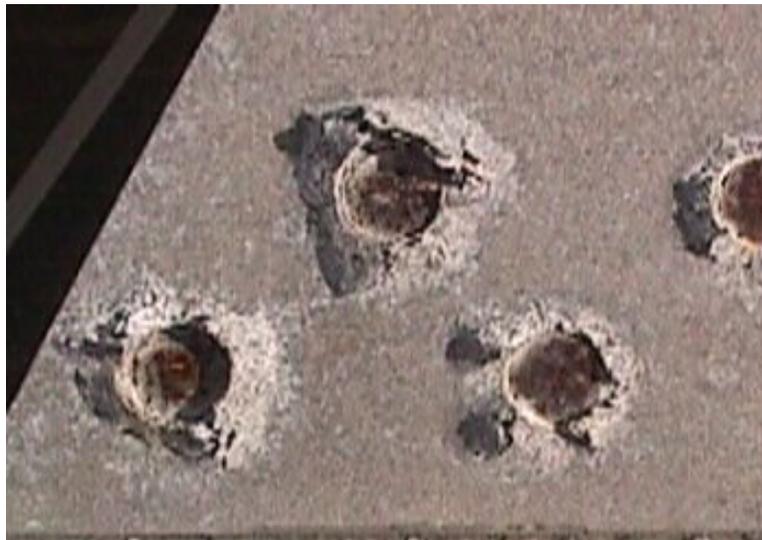
Figure 2 shows severe exfoliation corrosion at multiple sites around rivet holes.

Figure 2. Exfoliation corrosion at multiple sites, each near rivet holes.

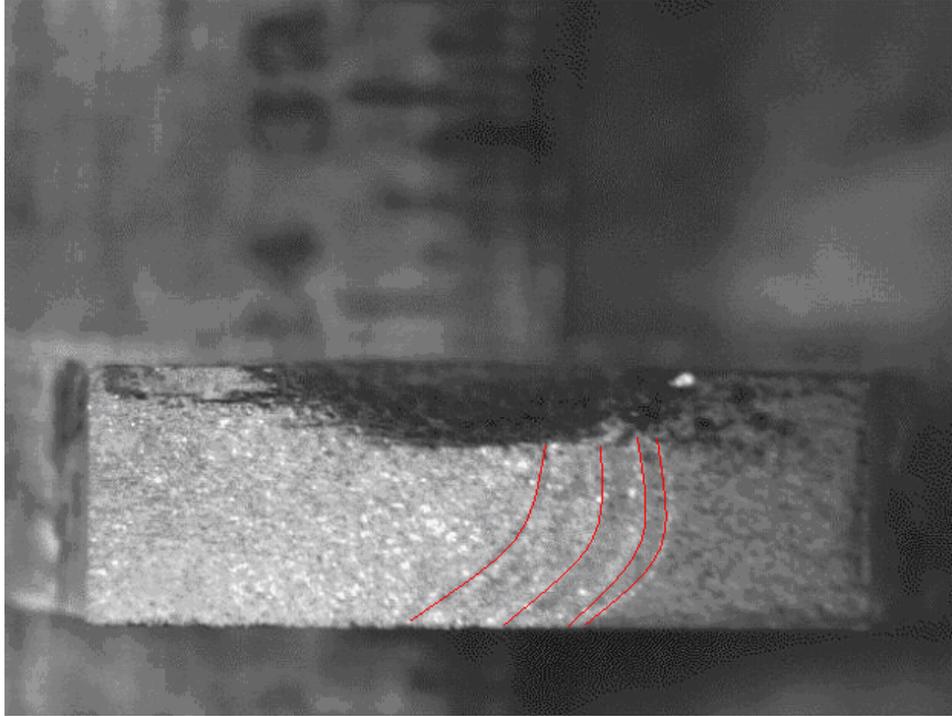
Figure 15. Specimen loaded in L direction with corrosion only on LT plane. Beach mark is the brighter part of the fracture surface and red marks help to enhance the crack growth bands. Scale marks in 1/64”.

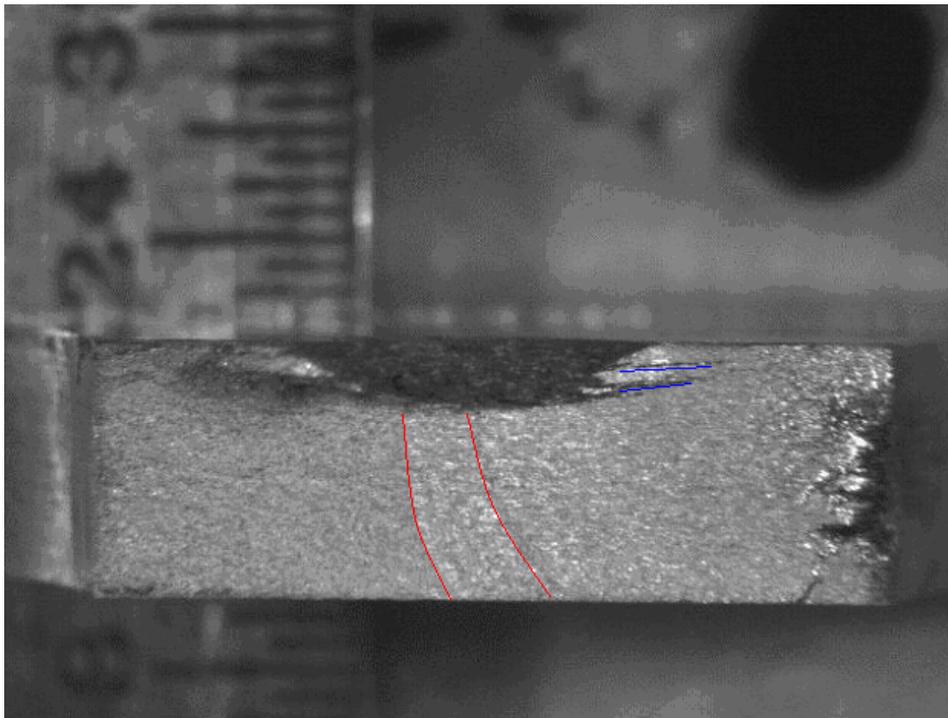
Figure 16. Optical microscope used to capture entire image of specimen. Magnification is about 7.5x with scale marks of 1/64-inch. Severe intergranular corrosion highlighted in blue can be seen from the left side of the corrosion on the LT plane. Also, crack growth bands are visible originating from the right side of the specimen, in red.

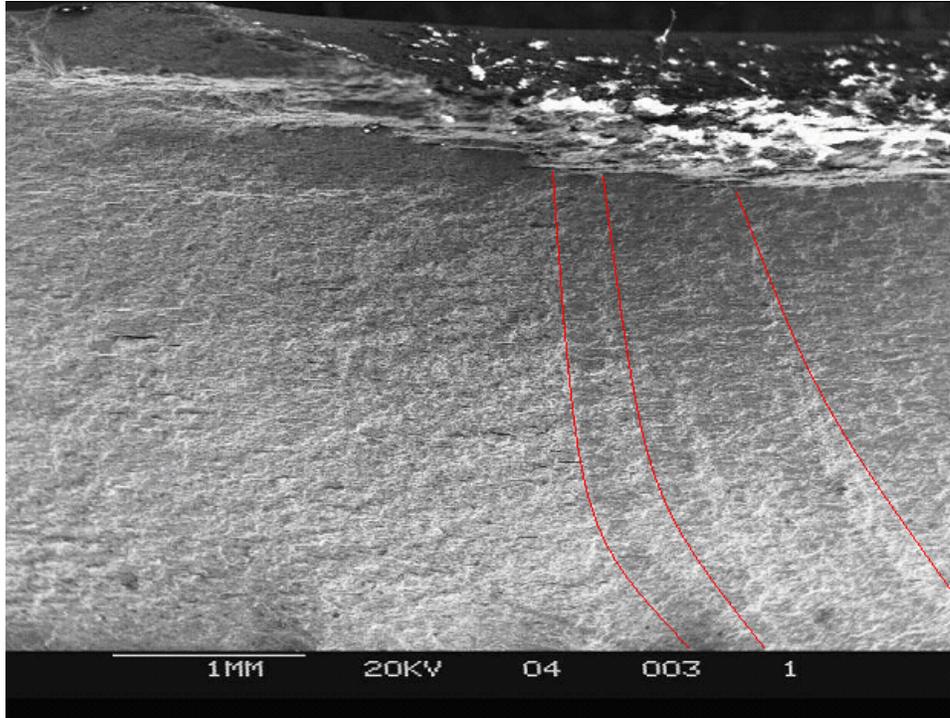
Figure 17. Central region of specimen with 20x in secondary mode to emphasize growth bands. No discontinuities along the corrosion surface seemed to be the cause for crack growth arrest, which leads to the assumption that the crack growth was in its final stage here before failure.

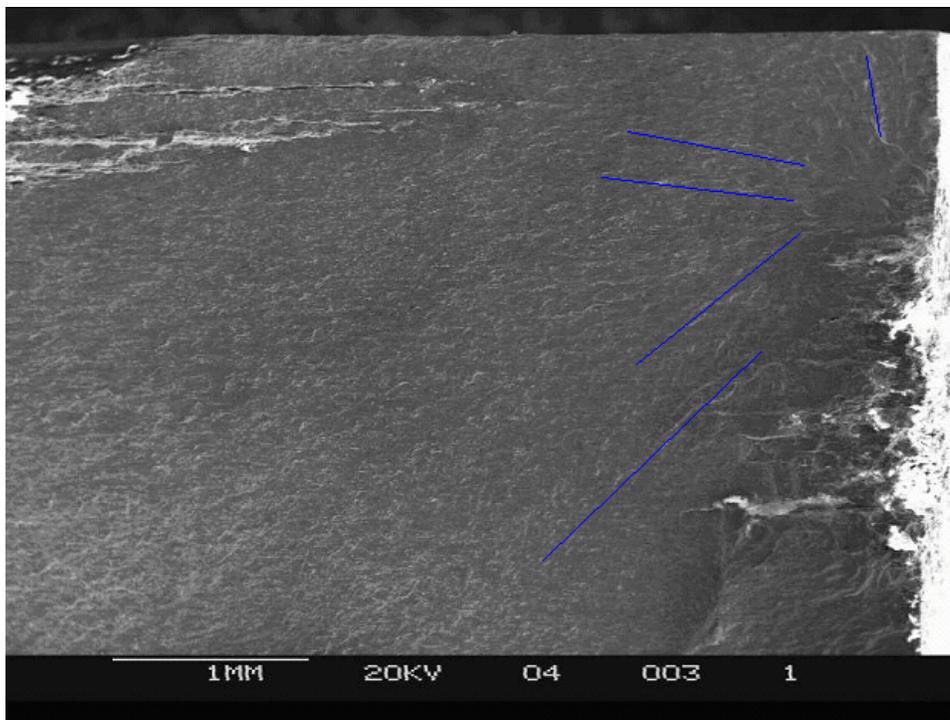
Figure 18. SEM image in secondary mode at 20x. Blue radial lines follow the path of river bands that literally point to the nucleation site.

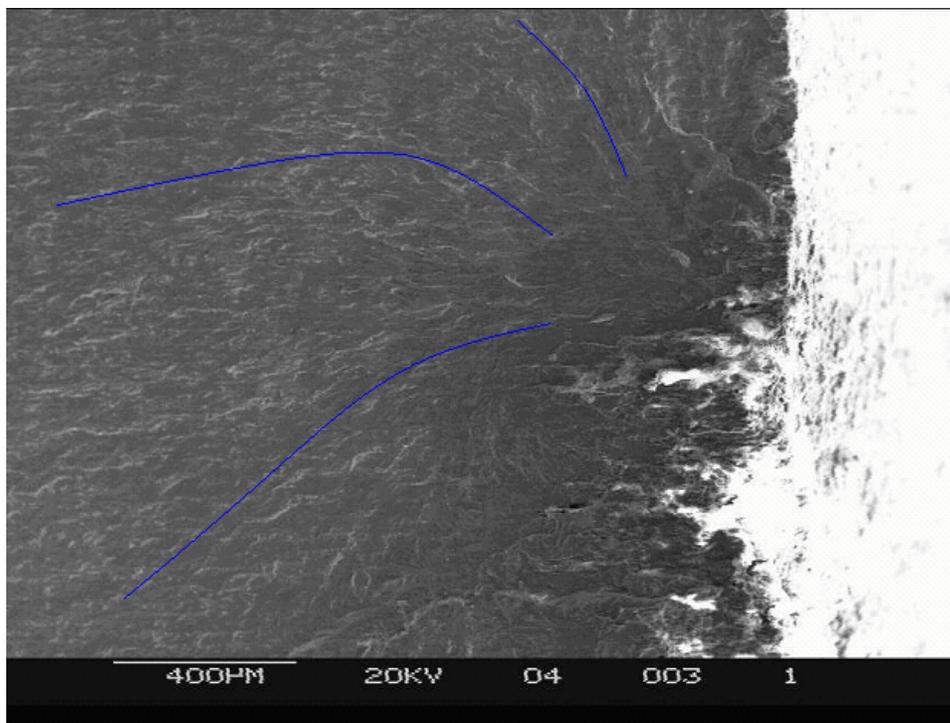
Figure 19. A SEM image of nucleation site at 50x in secondary mode. The nucleation occurs from extreme intergranular corrosion on the LS plane. Blue lines again follow the river bands to point to the nucleation site.

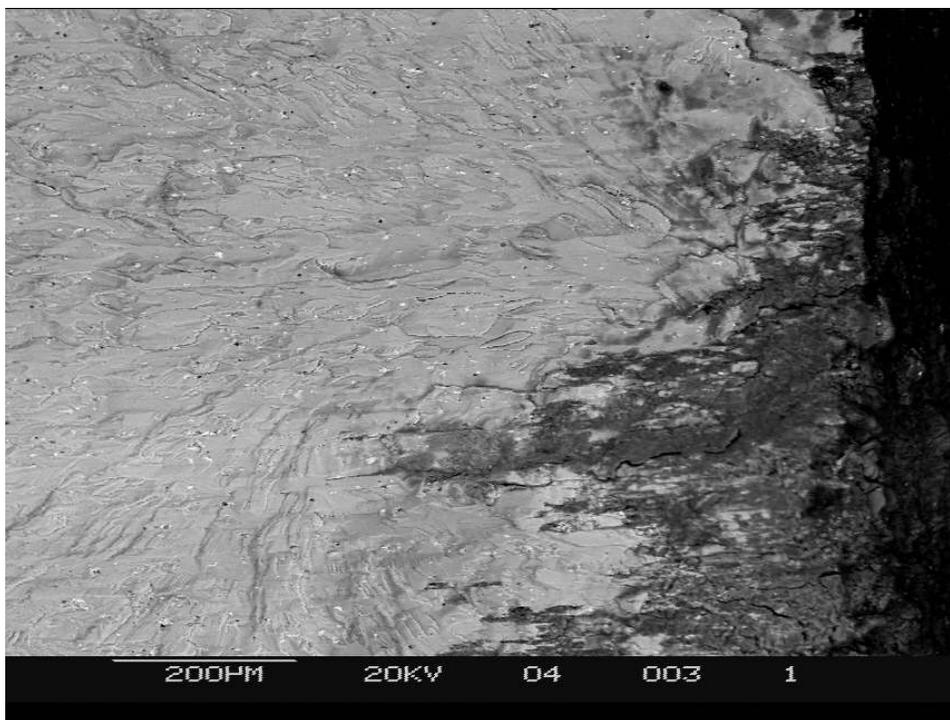
Figure 20. SEM image in back scatter mode at 100x to determine if there were any abnormal particles that may have caused nucleation at this site. Nothing irregular was found; therefore the nucleation most likely occurred from a stress concentration from corrosion.

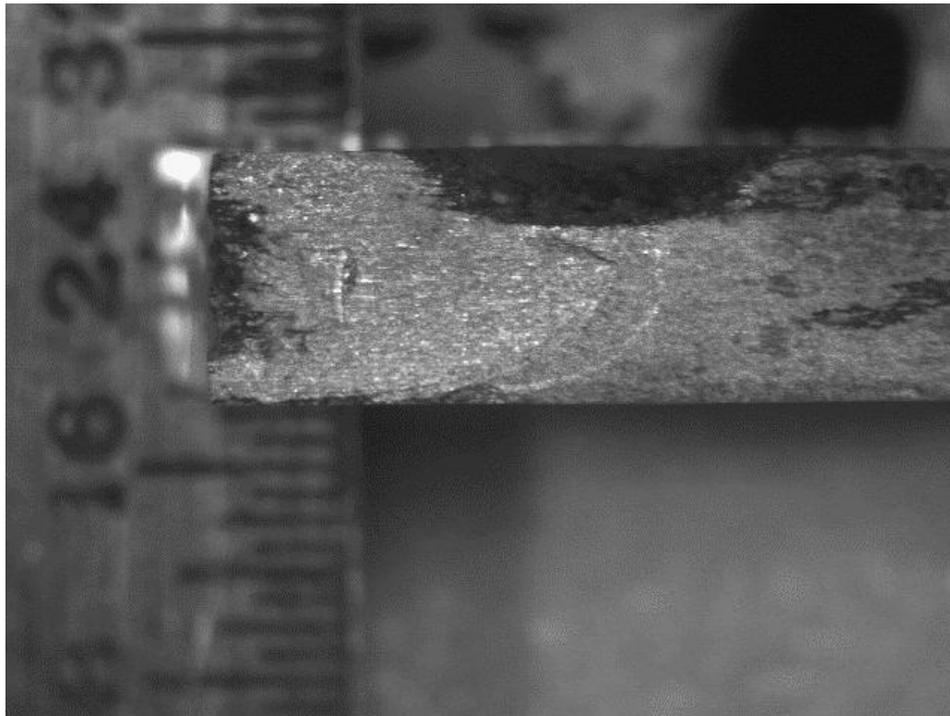
- e. *Nucleation seemed to be caused at the corner of the specimen between corrosion sites. Again, reason for this may be explained by the weakened surrounding material. See Figure 21 through Figure 23.*
- f. *This nucleation occurred away from the most susceptible corner, but it corrosion was not apparently a factor. See Figure 24 through Figure 26.*
- g. *This specimen had corrosion only on the side and corrosion seems to be the cause for this failure as beach marks are present which have formed circumferentially to the corrosion. See Figure 27 and Figure 28.*

Figure 21. Optical micrograph at 7.5x with scale marks of 1/64-inch. Nucleation clearly occurred on the left side of the specimen from a stress concentration caused by corrosion.

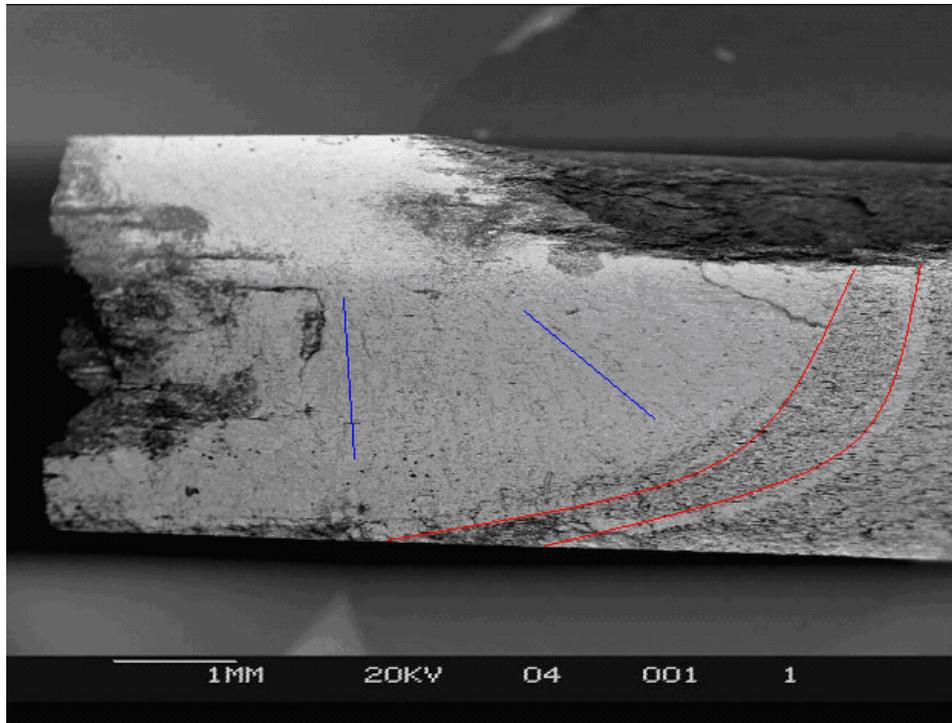
Figure 22. SEM image of left side of specimen where nucleation occurred. Image in back scatter mode and at 12x. Radial lines pointing to crack nucleation site are outlined in blue. Crack growth bands which are circumferential to the nucleation site are shown in red.

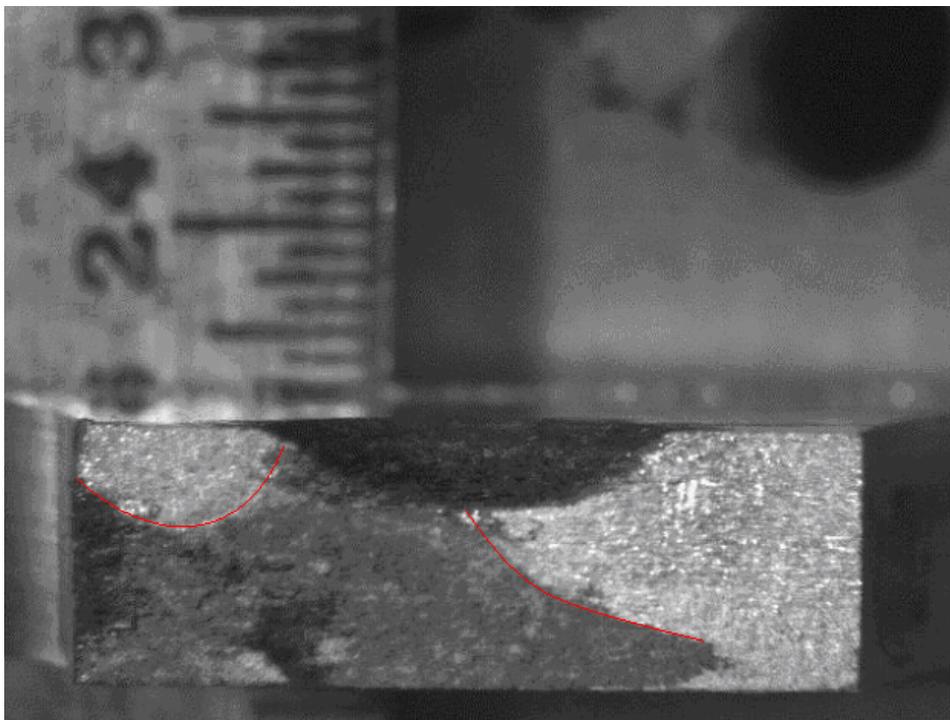
Figure 24. Optical microscopy at 7.5x with scale marks of 1/64-inch. The two shinier regions on the image are beach marks, which are outlined in red, and exist in two areas.

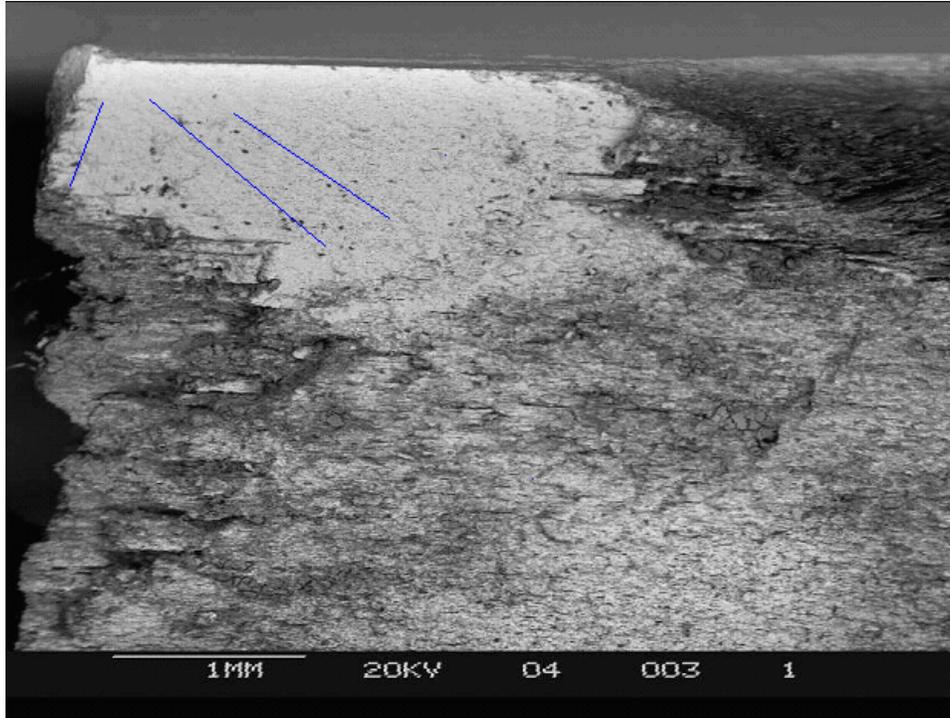
Figure 25. SEM micrograph of corner nucleation site at 20x in back scatter mode. River bands are indicated in blue. The area was a likely site for nucleation since two surrounding areas had severe damage.

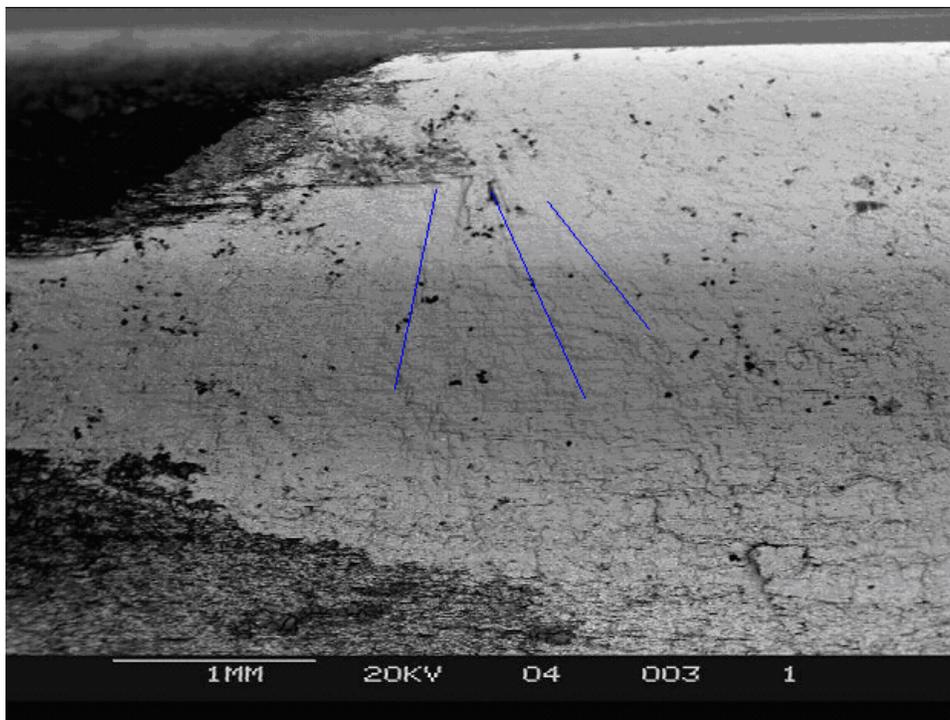
Figure 26. SEM image in back scatter mode at 20x. The initiation site is to the right of the corrosion on the LT plane. The extra intergranular corrosion is most likely the stress concentration factor that caused the nucleation site there.

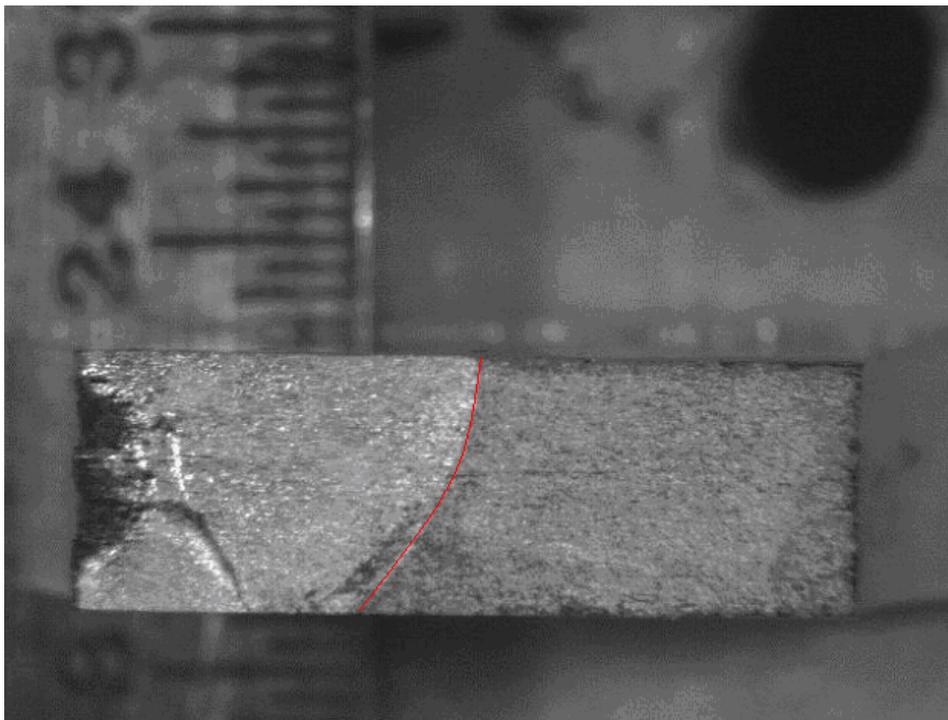
Figure 27. Optical microscope image of specimen, magnification is 7.5x with scale marks of 1/64-inch. Severe intergranular corrosion marks emanating from corroded area. The beach mark covers almost half of the specimen and is outlined in red.

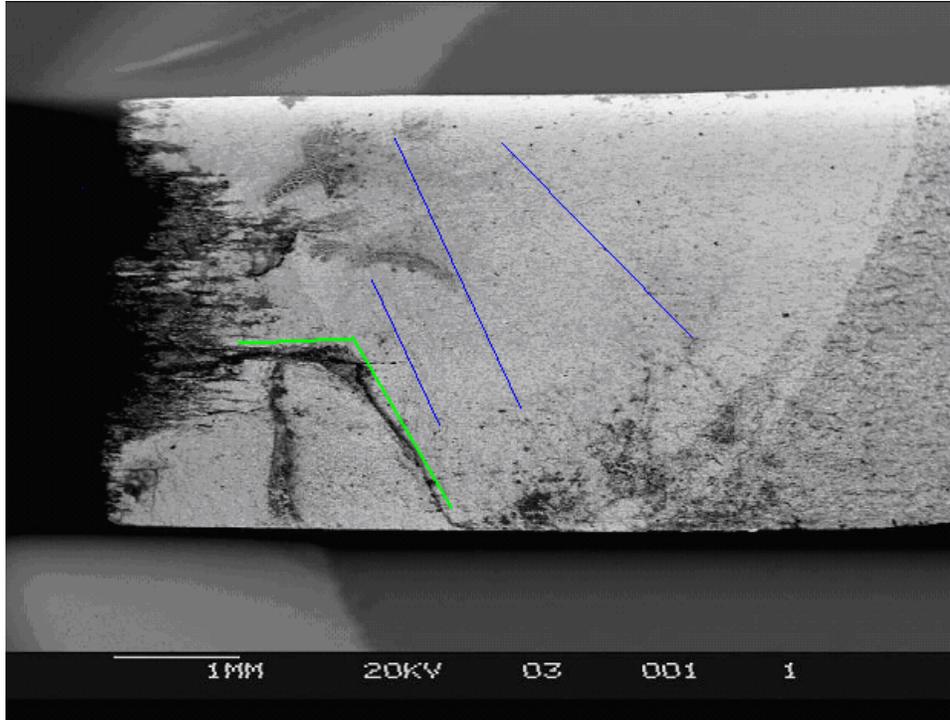
Figure 28. SEM image in back scatter mode at 13x. Corrosion on side of specimen with river bands in blue pointing toward a non-corroded area. The area on the lower left side of the picture is outlined in green and indicates a change of topography. This indicates shear on the fracture surface, perhaps caused by asymmetric loading in the test frame. Note it is not a likely cause for nucleation.

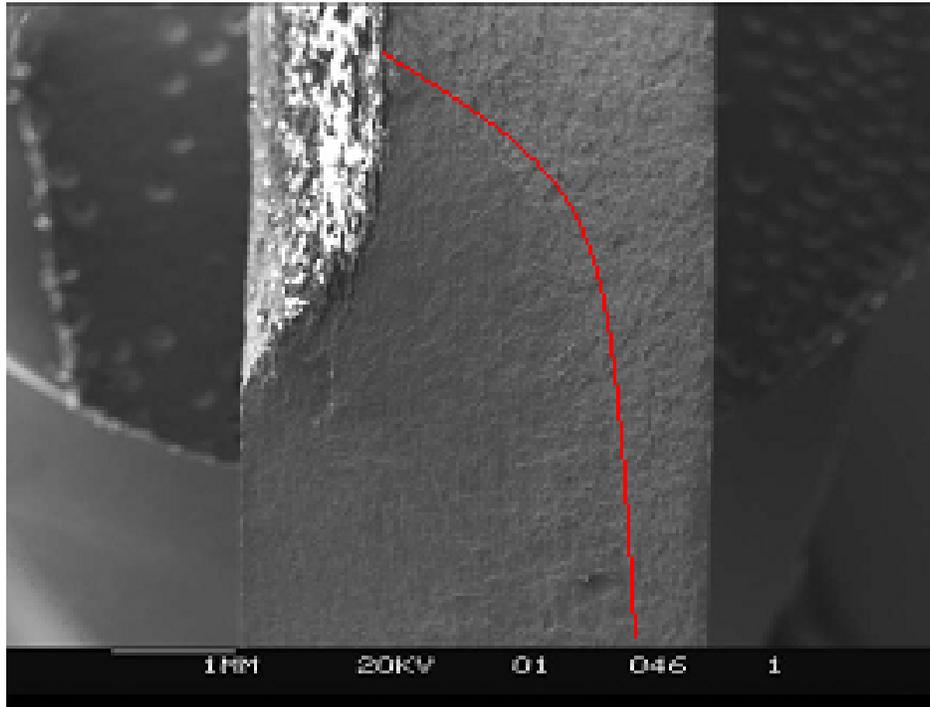
- The crack nucleated away from both corrosion sites at an "L" shape away from free surfaces. It seems as if the specimen experienced inadvertent shear loading in the test frame. See Figure 29 through Figure 32.*
- The crack here nucleated between corrosion on the side and on the front of the specimen. This area would be likely for failure due to the surrounding weakened ligaments. See Figure 16 through Figure 20.*
- This specimen had no corrosion on either side, yet it nucleated on the side of the specimen, most likely due to the K_t of the specimen design. See Figure 33 and Figure 34.*
- Corrosion conditions were on the front and side of the specimen and nucleated where expected—at the side of the specimen where corrosion existed. See Figure 35.*

Figure 29. Corroded area on front of specimen; bottom portion of specimen shows beach mark, 20x in secondary mode. The red follows the border slightly outside of the beach mark.

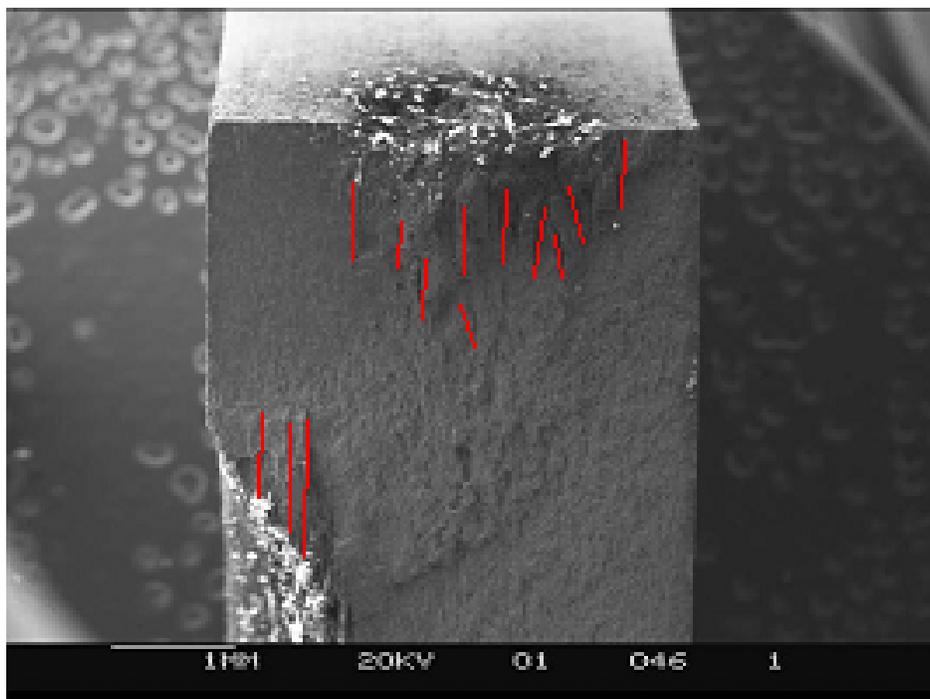
Figure 30. Top portion shows another corroded area with inter-granular corrosion, 20x in secondary mode. IGC is emphasized with red.

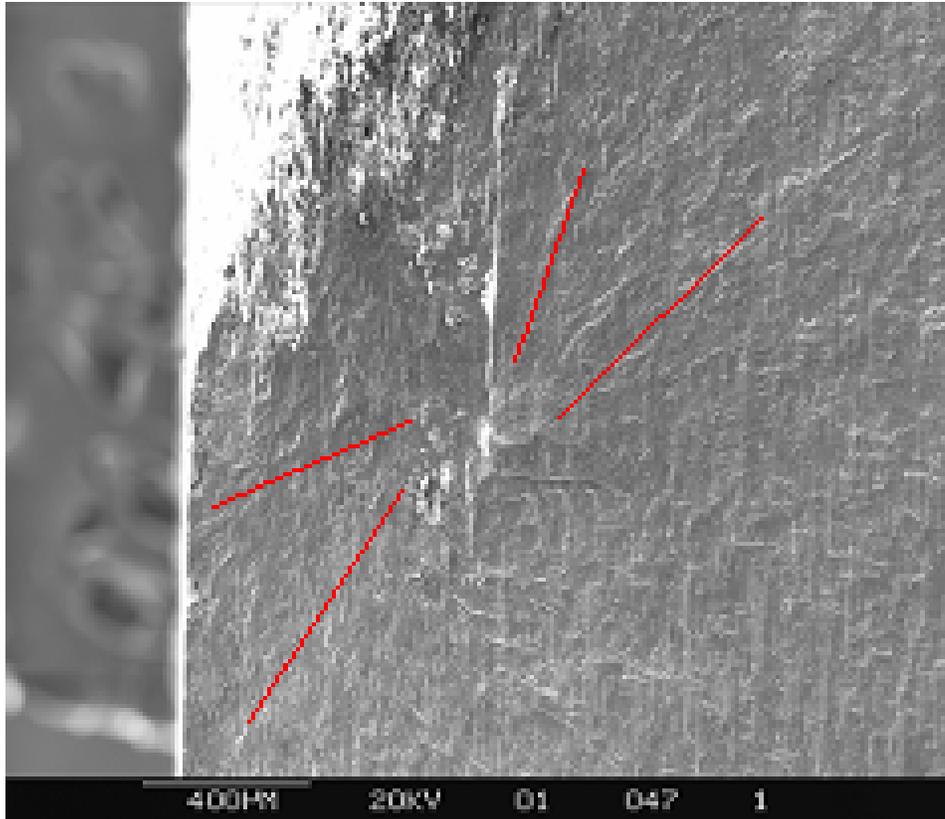
Figure 31. Under corroded area on front with L shape nucleating feature, 50x in secondary mode.

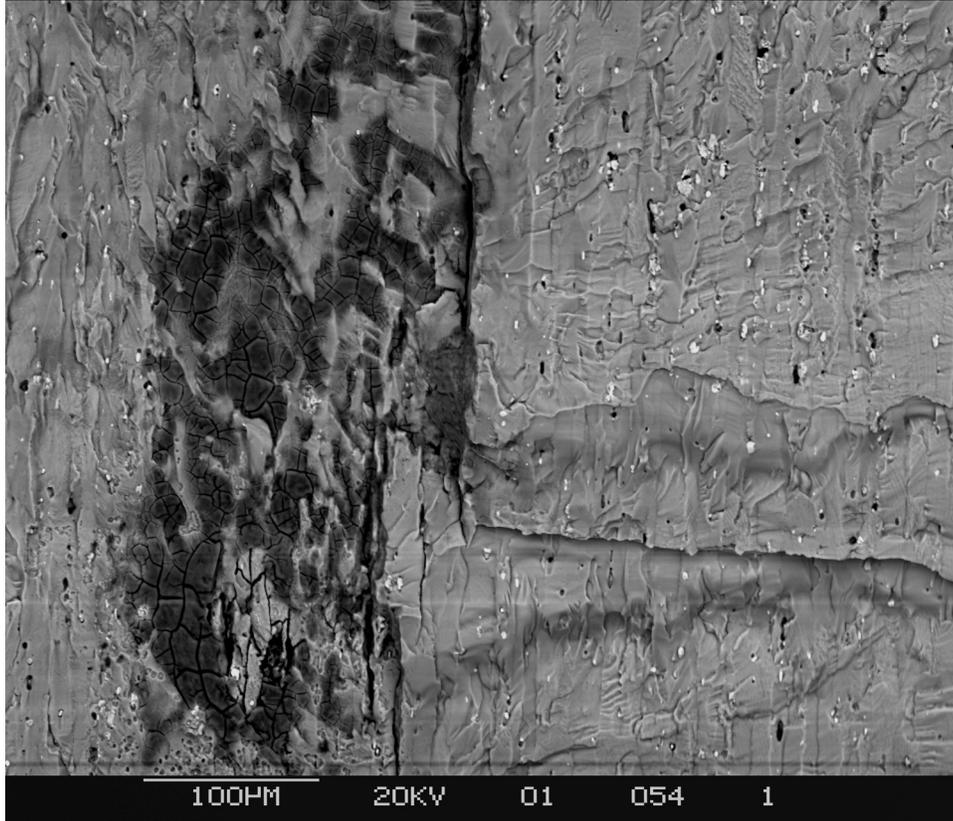
Figure 32. L-shape nucleation, 200x in back scatter. The vertical portion of the shape follows the grain boundaries, while the other part of the formation might have been caused by shear. Asymmetry in the test frame may have been to blame. The black marks in backscatter mode indicate no material abnormalities, hence this was not a cause for nucleation.

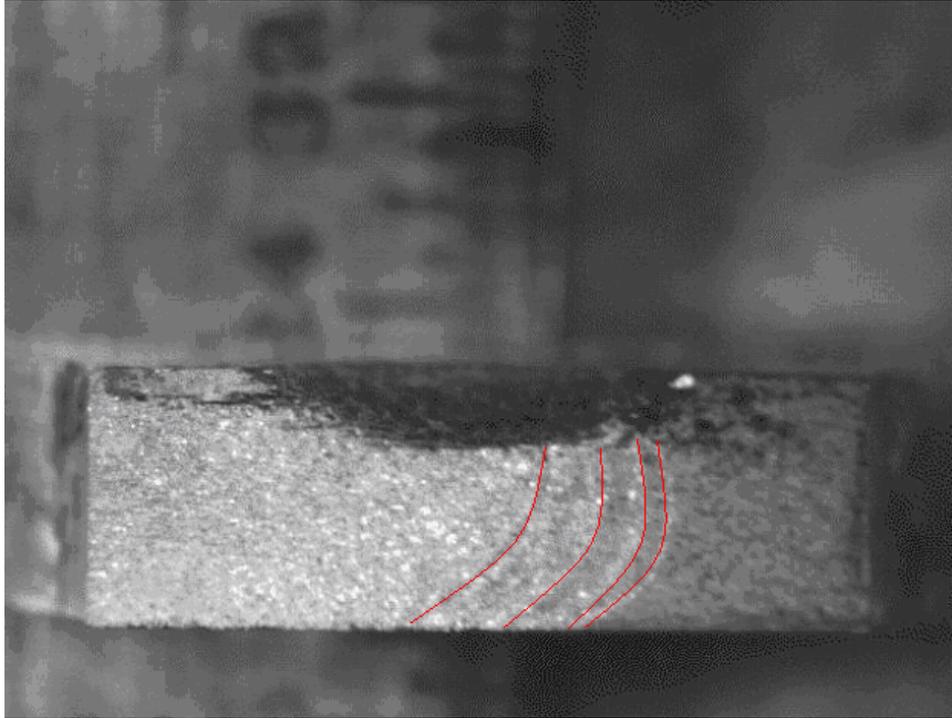
Figure 33. Specimen loaded in L direction with corrosion on LT plane. 7.5x optical magnification with scale in 1/64-inch increments. Red lines identify beach marks which indicate a nucleation site on the left side of the specimen—away from corrosion altogether.

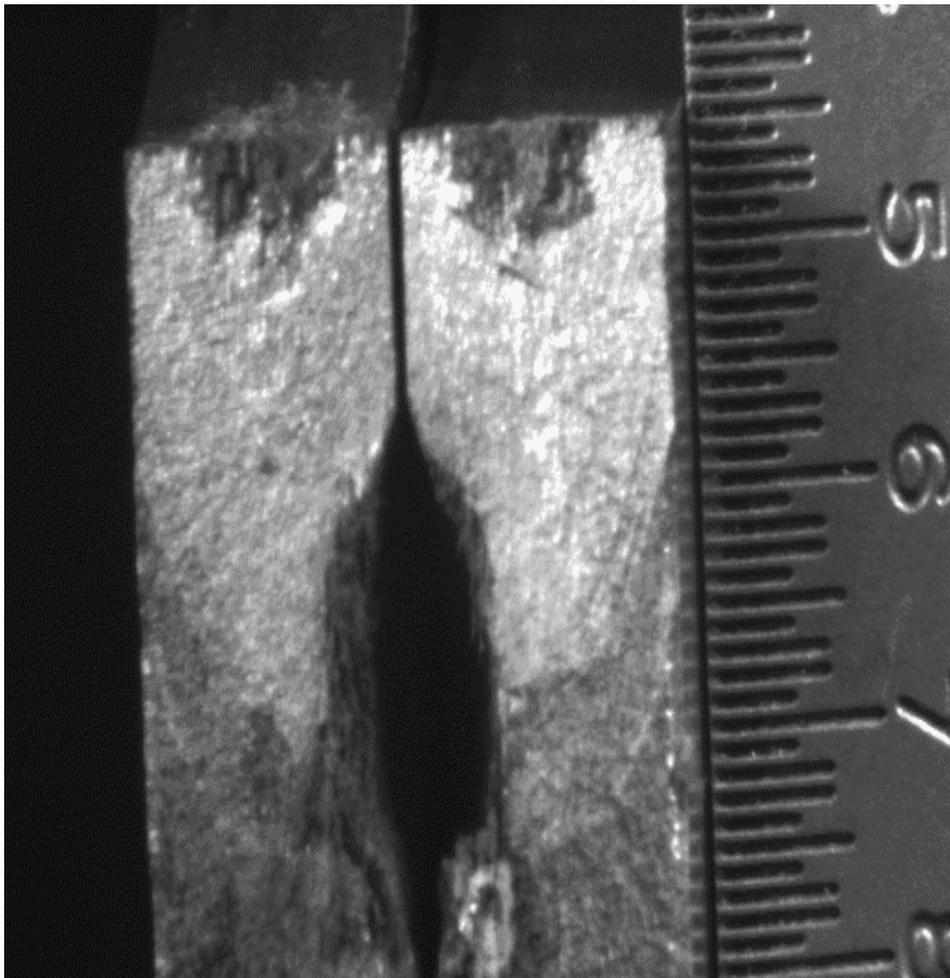
Figure 35. Fatigue cracking clearly nucleated at the side of the specimen where corrosion exists. Luster of the beach mark and radiating striations on both fracture surfaces are shown. Scale marks are in 1/100" increments.
