Falcon Sat-3

2nd Structural Engineering Model (SEM2)

Vibration Test and Mass Properties Measurement

Test Report

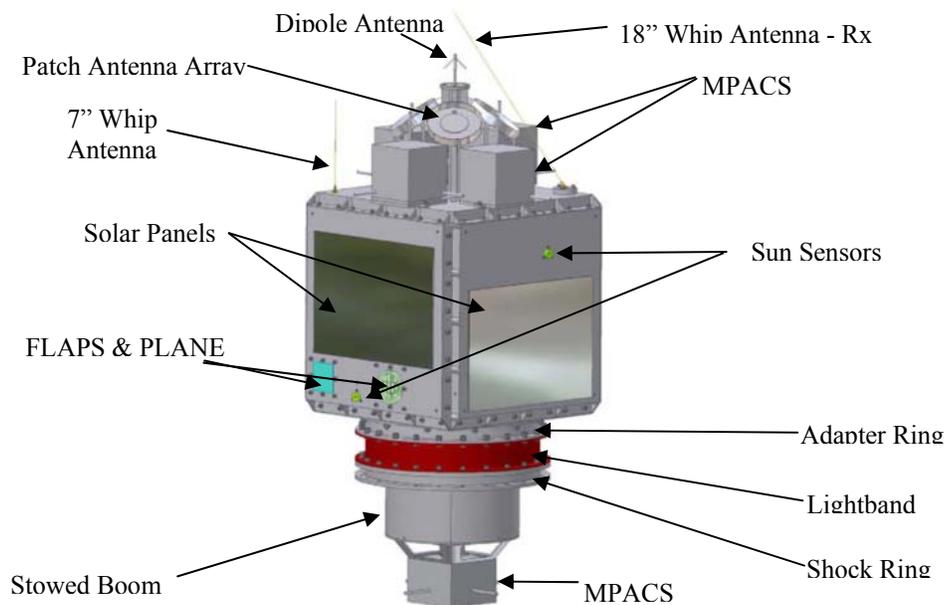
Figure 1 FalconSat-3 external configuration

The test article includes the mechanical avionics stack with mass simulators for the electronics and simulators for the payloads and the boom (stowed simulator) to provide for realistic structural loading of the structure while being tested.

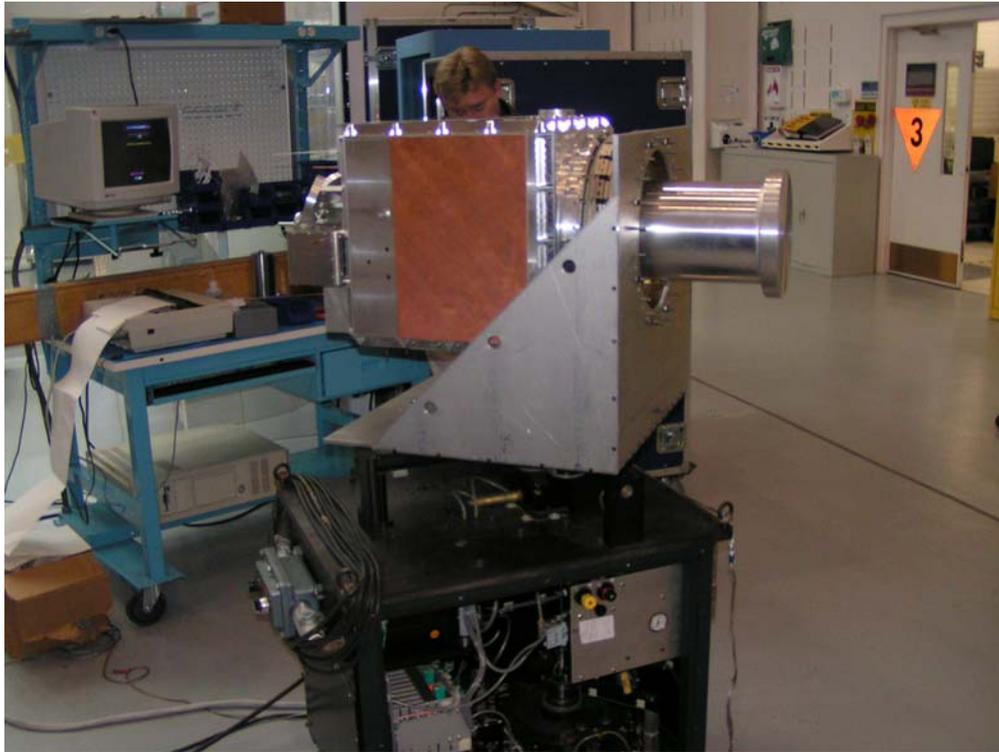
Figure 5 SEM2 mounted on the Mechanical properties table

The test article was mounted on the vibration table using a USAFA supplied extender and interface plate. The interface plate bolts to both the vibration slip table and directly to the head.

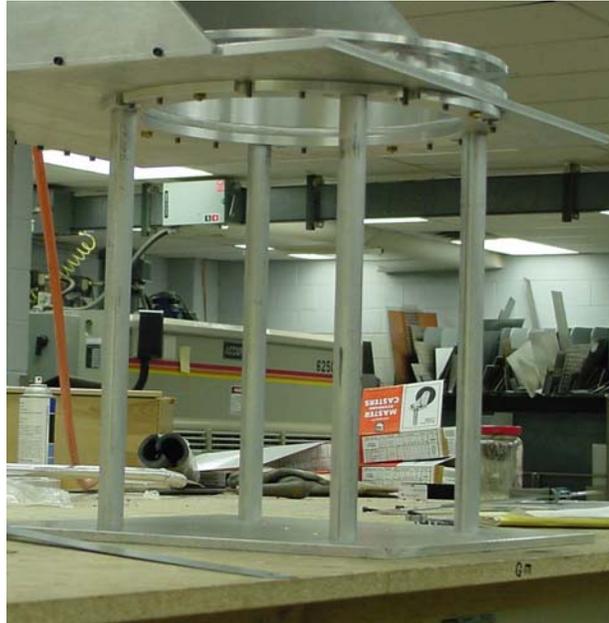
Figure 6 Vertical stand (shown mounted under Horizontal stand)

The vertical mounting interface was also used to support the horizontal interface during spacecraft assembly.

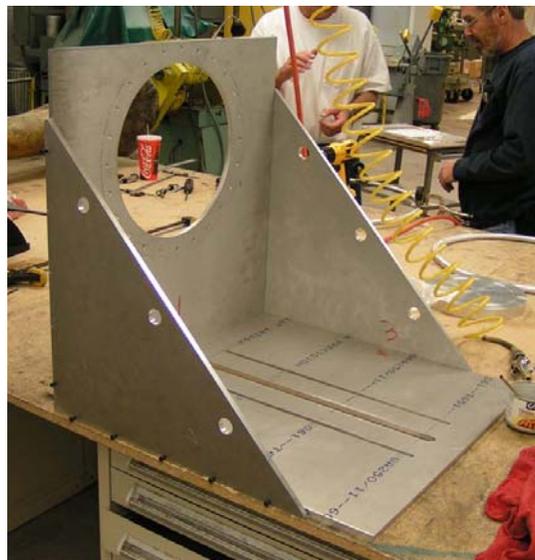
Figure 7 Horizontal mounting interface

The horizontal mounting bracket facilitated the rotation of SEM2 between horizontal and vertical positions. The composite was held at all times when lifted, to prevent any unwanted rotation; and no personnel stood under a suspended load at any time. The interface was mounted onto the vertical interface for support and to clear the spacecraft boom when assembled. The horizontal mount had an additional leg to support it: this was assembled before the interface was positioned onto the vertical stand. The satellite was then lowered onto the interface, and eight nuts were assembled onto the studs that were cleared by the vertical stand. Two long (6-10 feet) straps were connected to the highest side holes. The composite was then lifted while personnel held onto the interfaces. When the assembly was lifted several feet off the ground it was rotated to the horizontal position and then moved over to the Mass Properties table. The interface had slotted mounting holes to allow the satellite to be mounted at its CoG over the rotation axis of the table. When the composite had been mounted and bolted onto the table the vertical support and the additional leg were removed. The lifting straps were not removed before the composite was securely bolted on the table.

To measure the inertia in the cross axis the procedure was reversed, the satellite rotated 90 degrees on the stand, and the composite re-mounted onto the table.

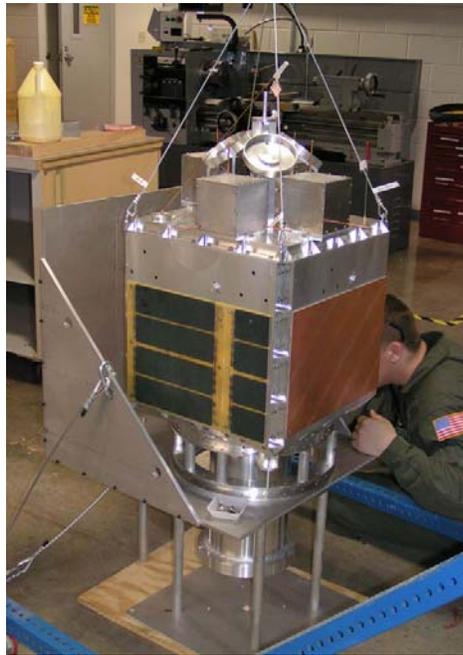
Figure 9 Lifting cables used for assembling spacecraft on L-bracket

The spacecraft was not lifted through its lifting points with either the vibration interface or the horizontal mass properties interface attached. Only the vertical mass properties interface was light enough to be lifted through the spacecraft. The other interfaces have lifting points themselves that allowed lifting with or without the spacecraft attached.

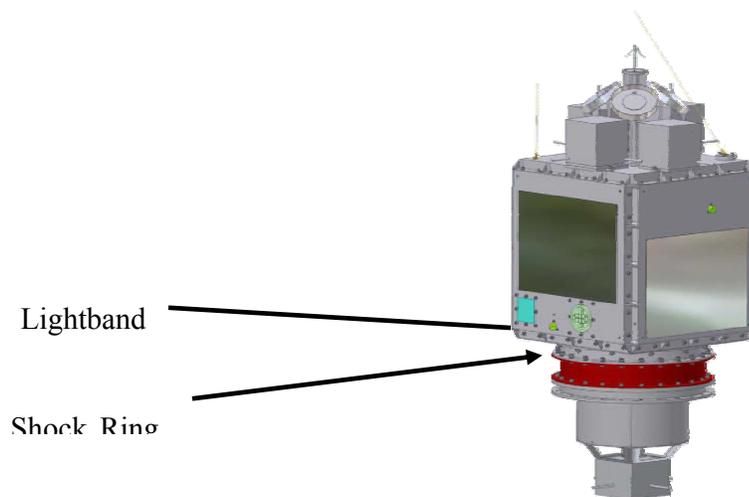
Figure 11 Lightband and Shock Ring location

For vibration testing, the SEM2 was mounted to the shaker fixture with an USAFA supplied extender tube, as the boom protrudes below the mounting interface of the Shock Ring. This extender fixture allowed mounting of the SEM2 with and without the Shock Ring. The interface plate bolts to both the vibration slip table and directly to the head. The bolts between the interface and the vibration table were assembled and torqued by AEF staff. The interface has attachment points for straps to facilitate lifting.

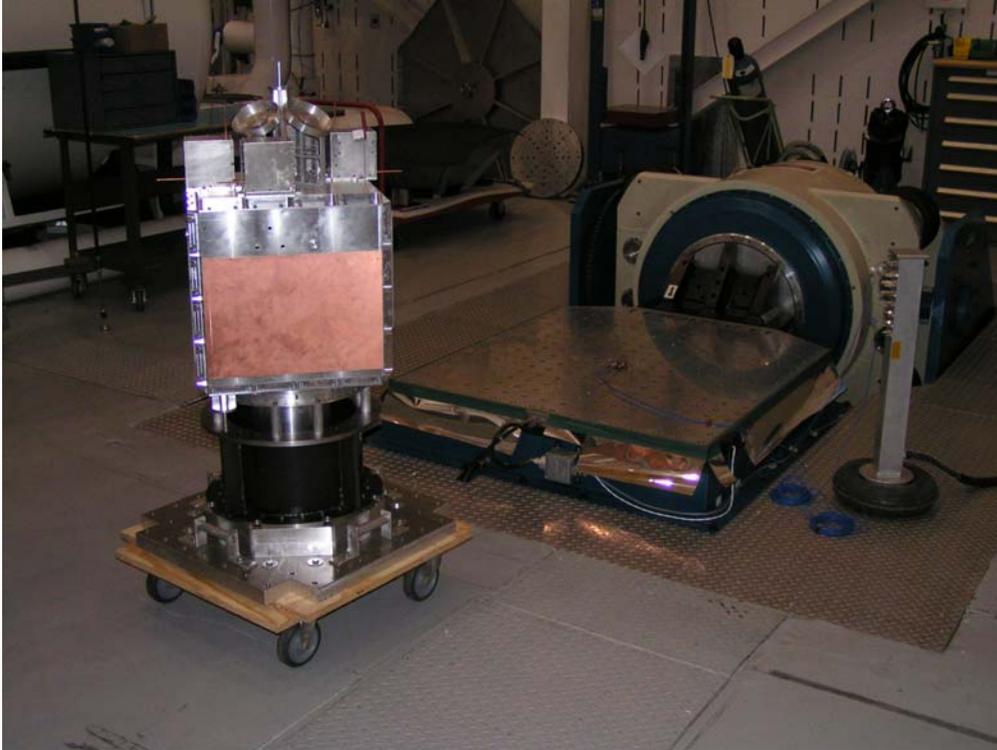
Figure 12: S/C attached to mounting bracket and plywood cart.

The SEM2 spacecraft model was shipped between USAFA and AEF by mounting it on the Horizontal Mass properties interface. This provided the shortest height, which made it simpler to handle and put in a van. The horizontal bracket also provided protection to SEM2 by partially surrounding it, and it provided convenient lifting points for handling and restraining. The Horizontal stand was mounted on a sheet of plywood sized to be larger than the spacecraft footprint. Caster were then attached to this piece of plywood in order to assist in transportation and handling.

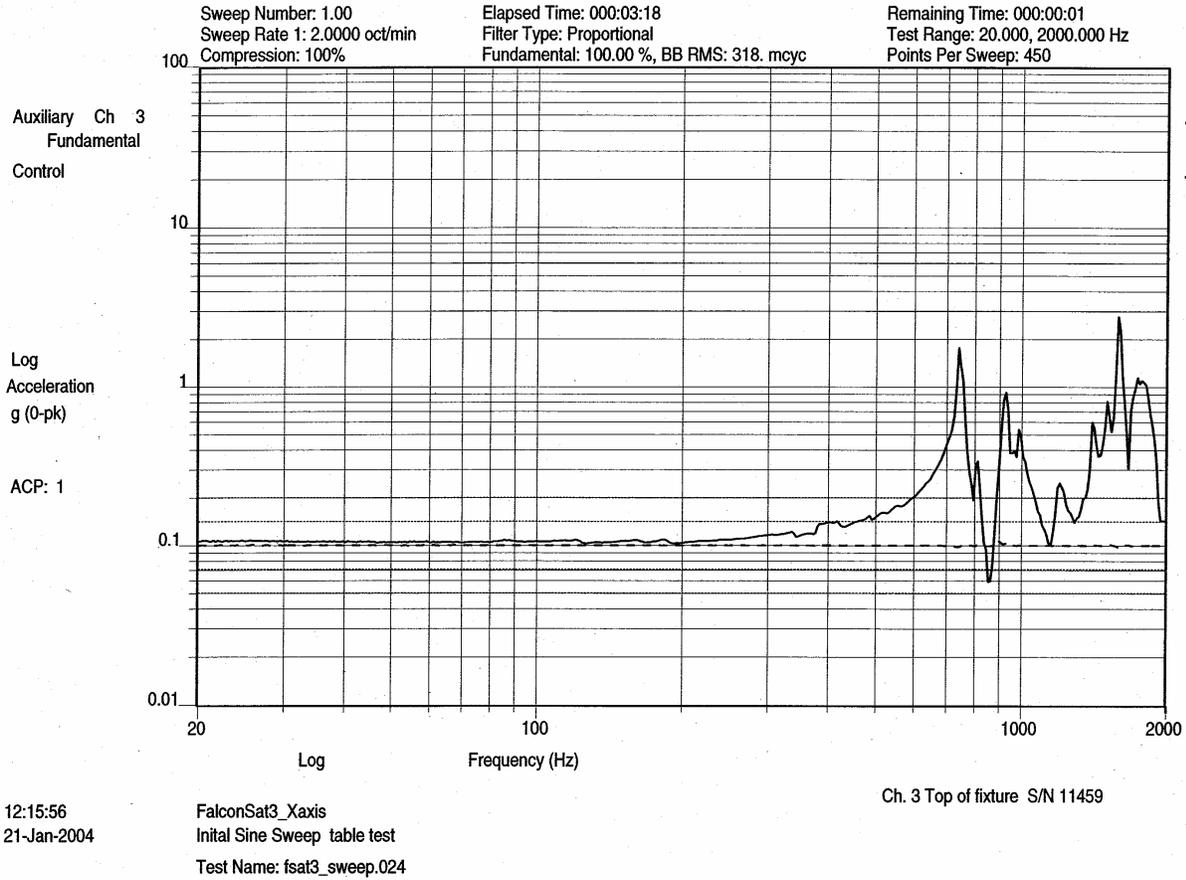
Figure 15: Initial Sine Sweep of Test Fixture

Once the vibe table was returned to service, the sine sweep was repeated. Results indicated the first mode natural frequency of the test fixture was ~750 Hz.

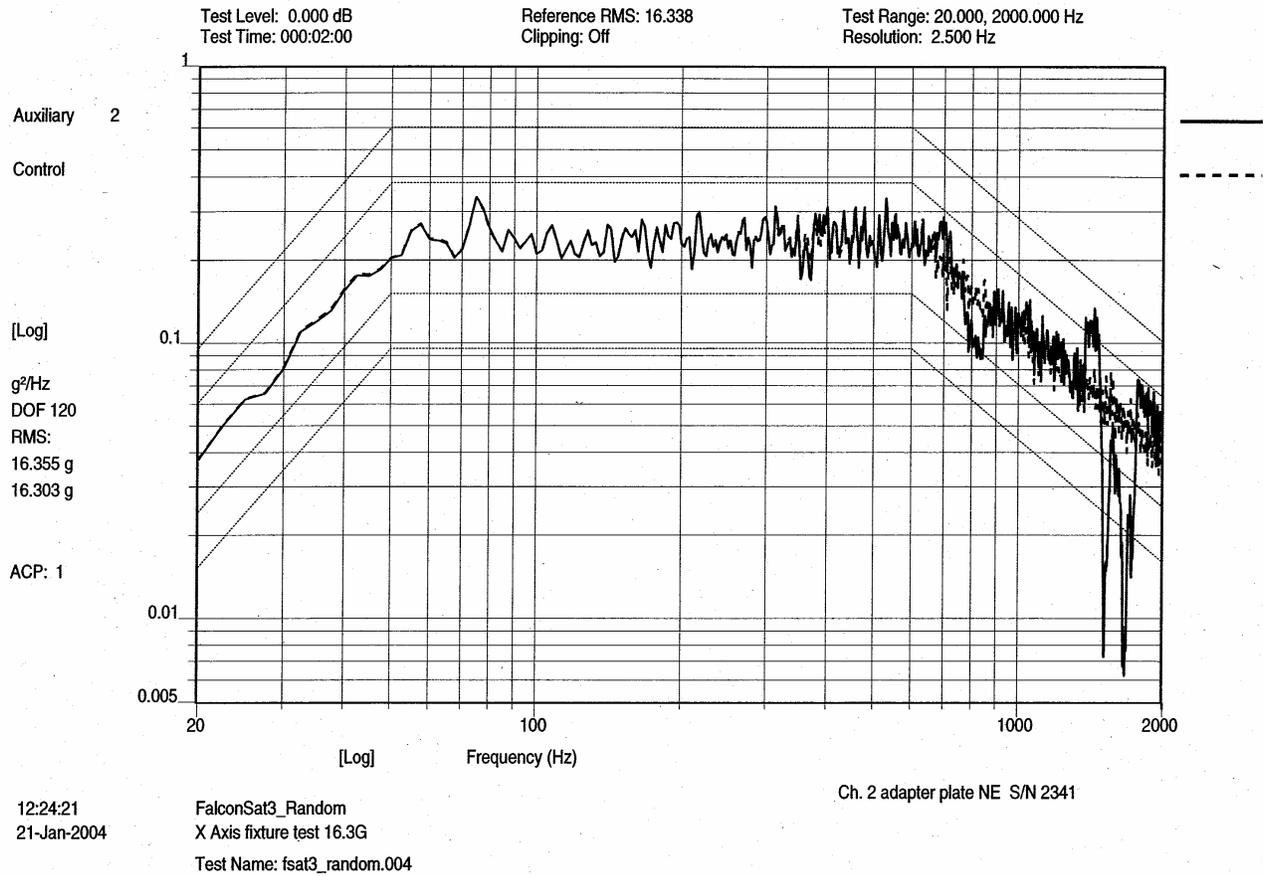
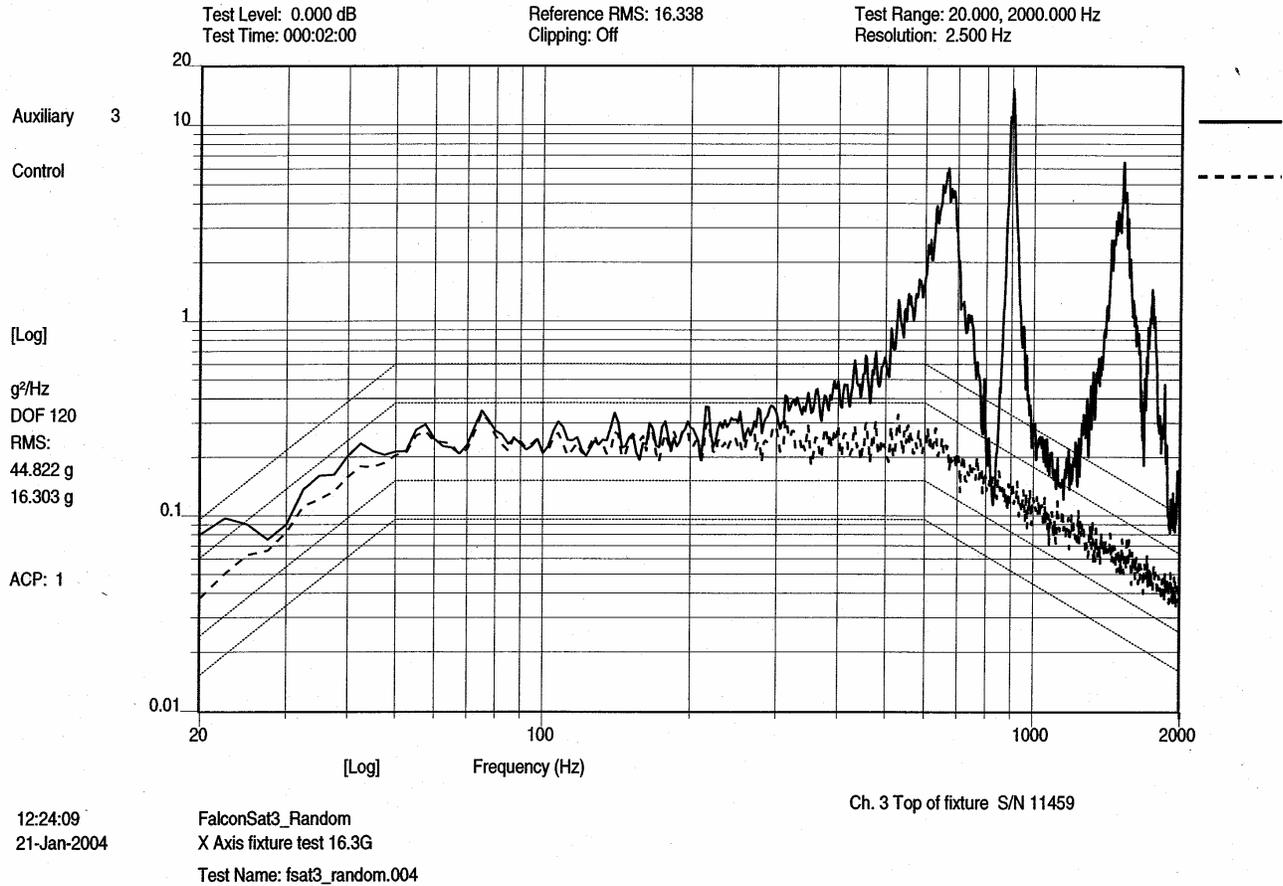
The test facility was able to perform this test at the required levels. No malfunctioned occurred during the test and no failure was observed.

Figure 16: Random Vibe plot from the Adapter Plate

Figure 17: Random vbe results from test fixture

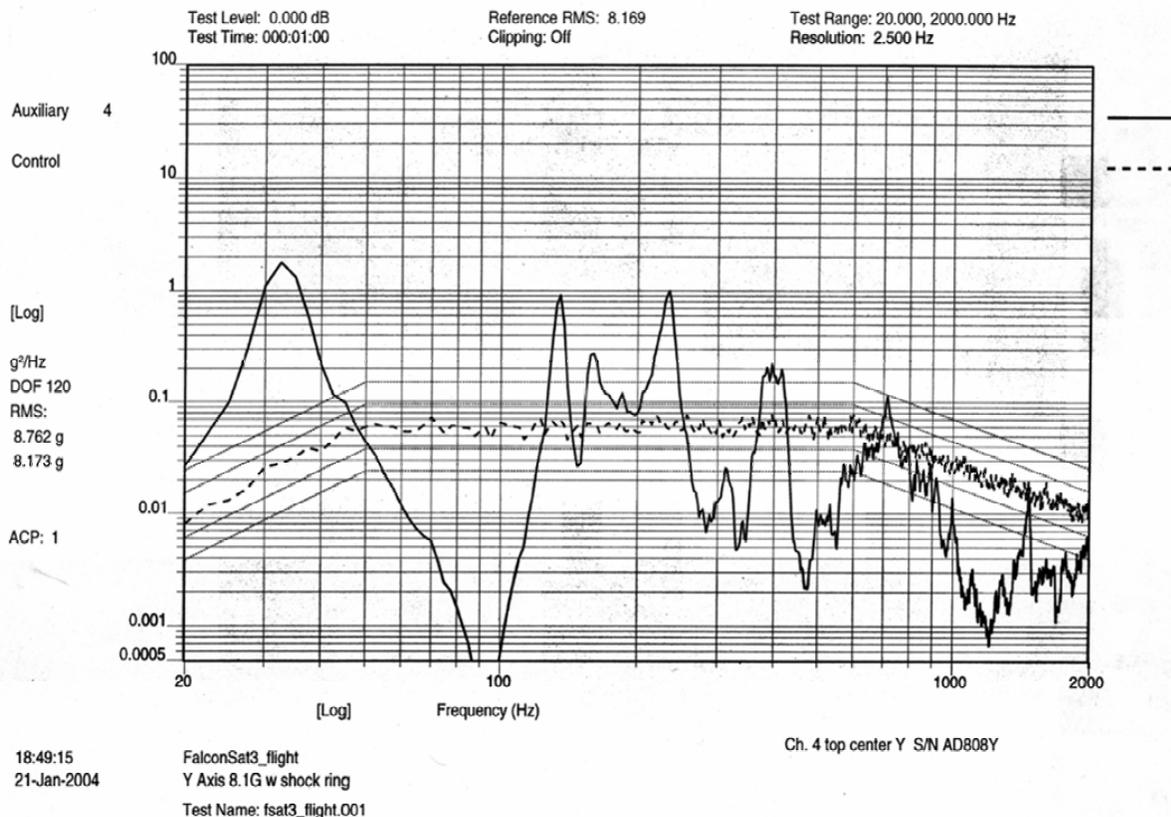
Figure 19: Initial Sine Sweep, Top Center Y

These frequencies are illustrated in the following figure which depicts the initial sine sweep response of the top panel with the shockring. As you can see, the primary mode is not greater than the 35 Hz ESPA requirement. However, this likelihood was briefed at the CDR and will be contained in the FalconSAT-3 ICD to ESPA. In the Y panel Y axis there was suspected saturation or other problem resulting in skewed results. The pre and post test sine sweep varied in the fundamental frequency. This was due to the temperature change in the visco elastic material (VEM) that shifted the fundamental frequency. In the future a second post test sine sweep should be conducted after the VEM has cooled in order to get a better feel for the result on the structure from the test.

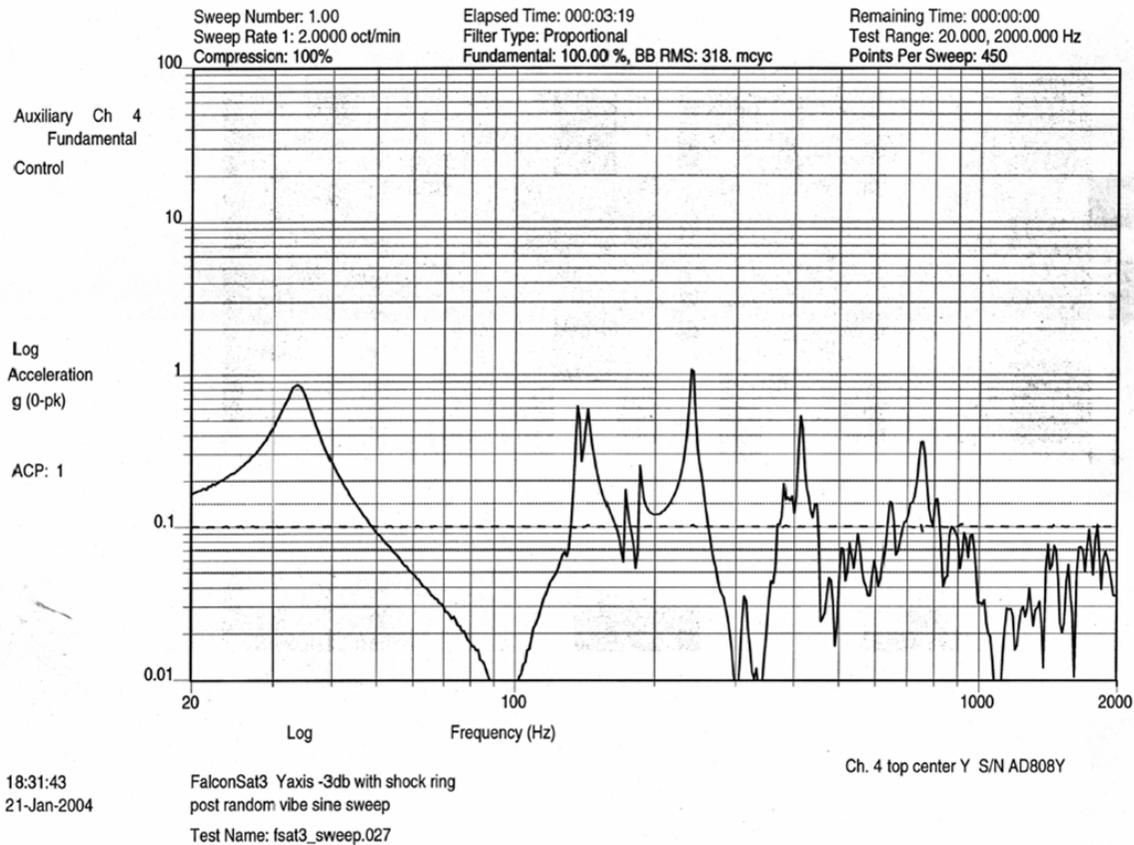
Figure 20: Post Characterization-Level Random Vibe Sine Sweep

Following this random vibration test, a sine sweep was conducted to the levels indicated in Table 14 Sine sweep vibration specification. In order to verify structural integrity after the SEM-2 was subjected to the above environment, we checked the torques of the fasteners following the post-testing sine sweep. After a reasonable sample of the bolts were checked for the proper torque it was determined that less than 20% of the torque had been lost on any one bolt. The plot below illustrates the sine sweep results for the top panel following this test. As you can see, the fundamental frequency following this test remained almost unchanged. Plots remain unchanged, for the most part, from one accelerometer to the next.

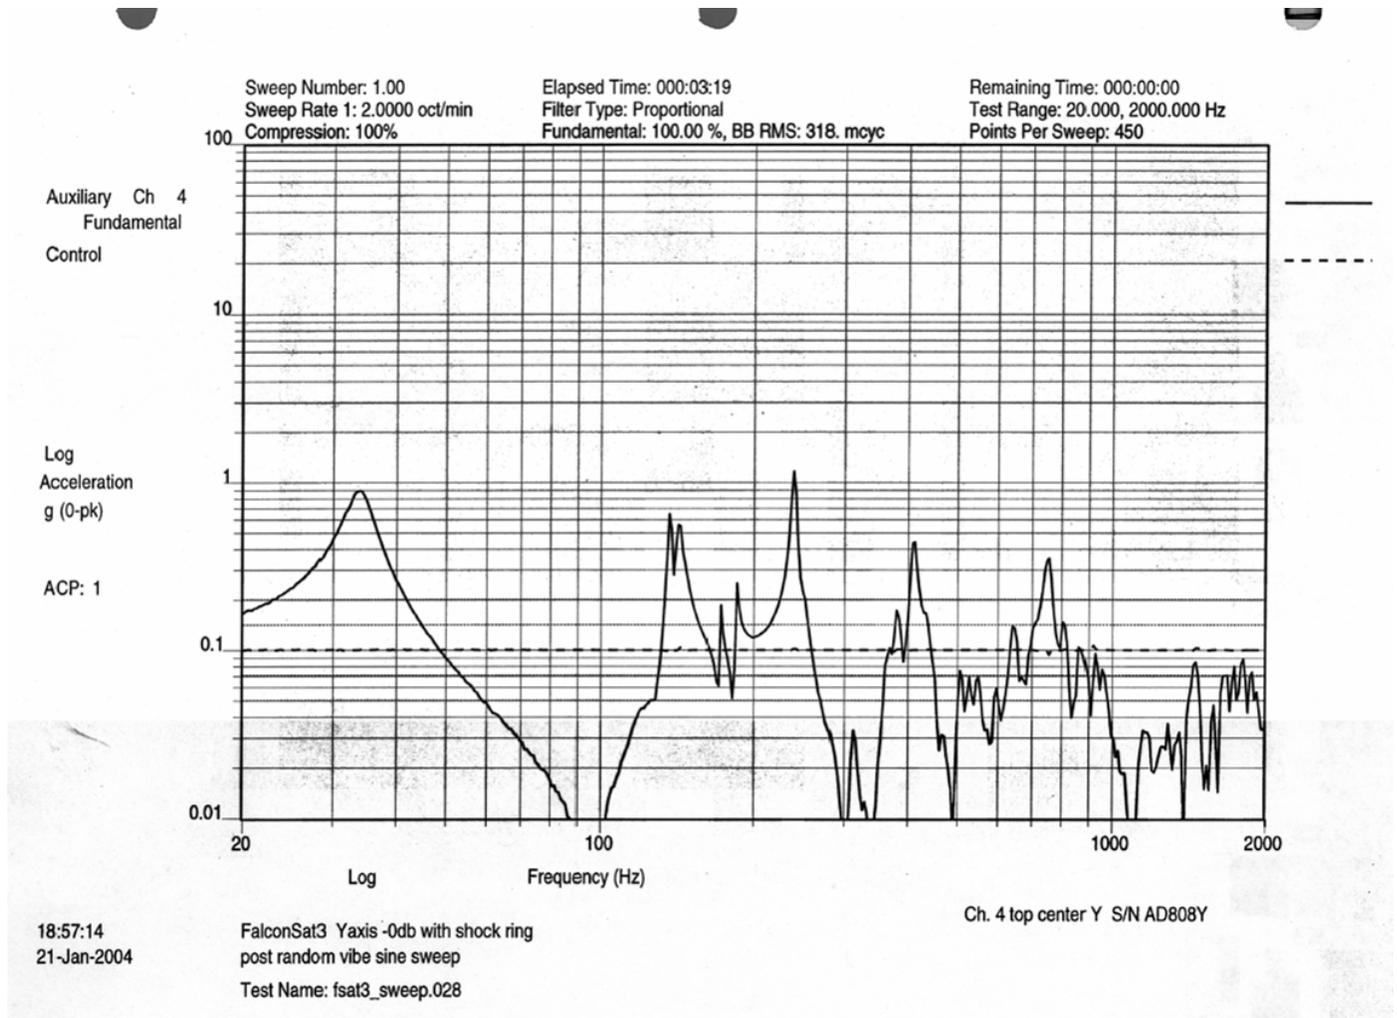
Figure 22: Post Acceptance-Level Random Vibe Sine Sweep

determined that less than 20% of the torque had been lost on any one bolt. The plot below illustrates the sine sweep results for the top panel following this test. As you can see, the fundamental frequency following this test remained almost unchanged. Plots remain unchanged, for the most part, from one accelerometer to the next.

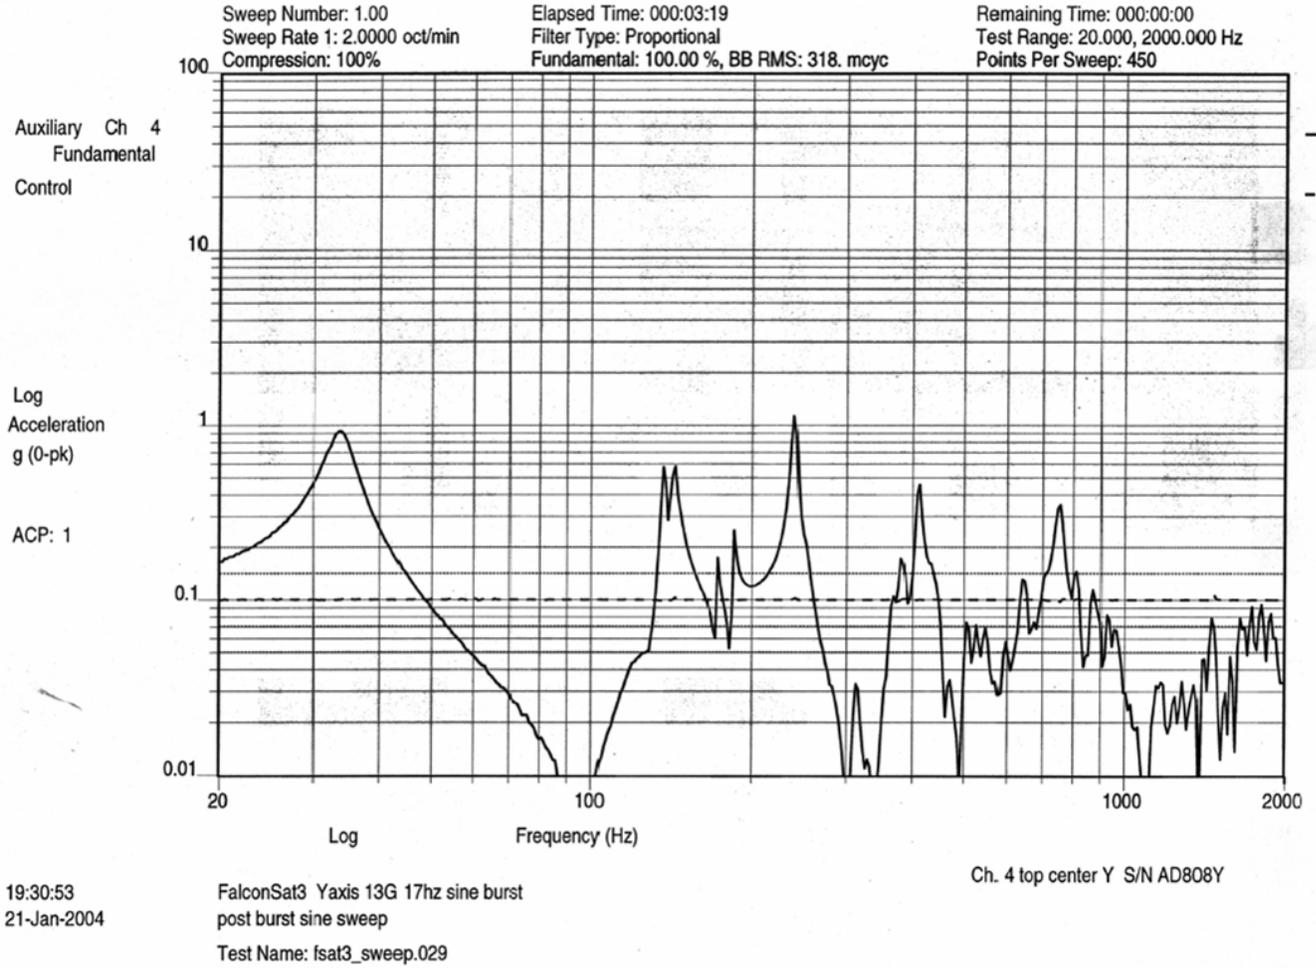
Figure 23: Post Sine Burst Sine Sweep

Following this sine burst test, a swine sweep was conducted to the levels indicated in Table 14 Sine sweep vibration specification. In order to verify structural integrity after the SEM-2 was subjected to the above environment, we checked the torques of the fasteners following the post-testing sine sweep. After a reasonable sample of the bolts were checked for the proper torque it was determined that less than 20% of the torque had been lost on any one bolt. The plot below illustrates the sine sweep results for the top panel following this test. As you can see, the fundamental frequency following this test remained almost unchanged, indicating structural integrity. Plots remain unchanged, for the most part, from one accelerometer to the next. There was a problem with the with the SEM needing low frequency response in order to avoid significant dynamic gain in the response.

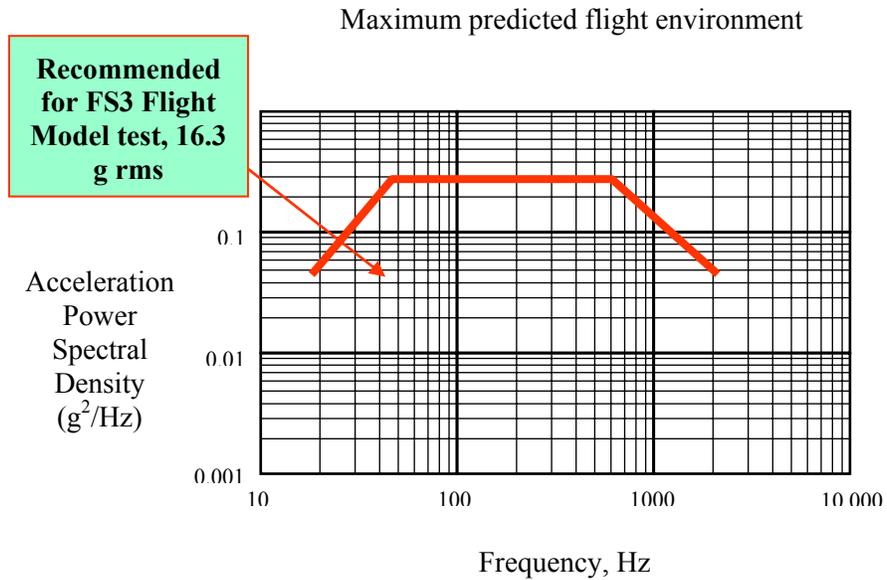
Figure 24: FalconSAT-3 flight-level power spectral density.

Random vibration qualification levels are shown in Table 20 FS-3 Qualification random vibration level and Figure 24: FalconSAT-3 flight-level power spectral density.. These levels represent +6dB above the flight level. Normally, the qualification is done for a full 2 minutes. However, based on recommendation from CSA, the duration of this test was held to 1 minute.

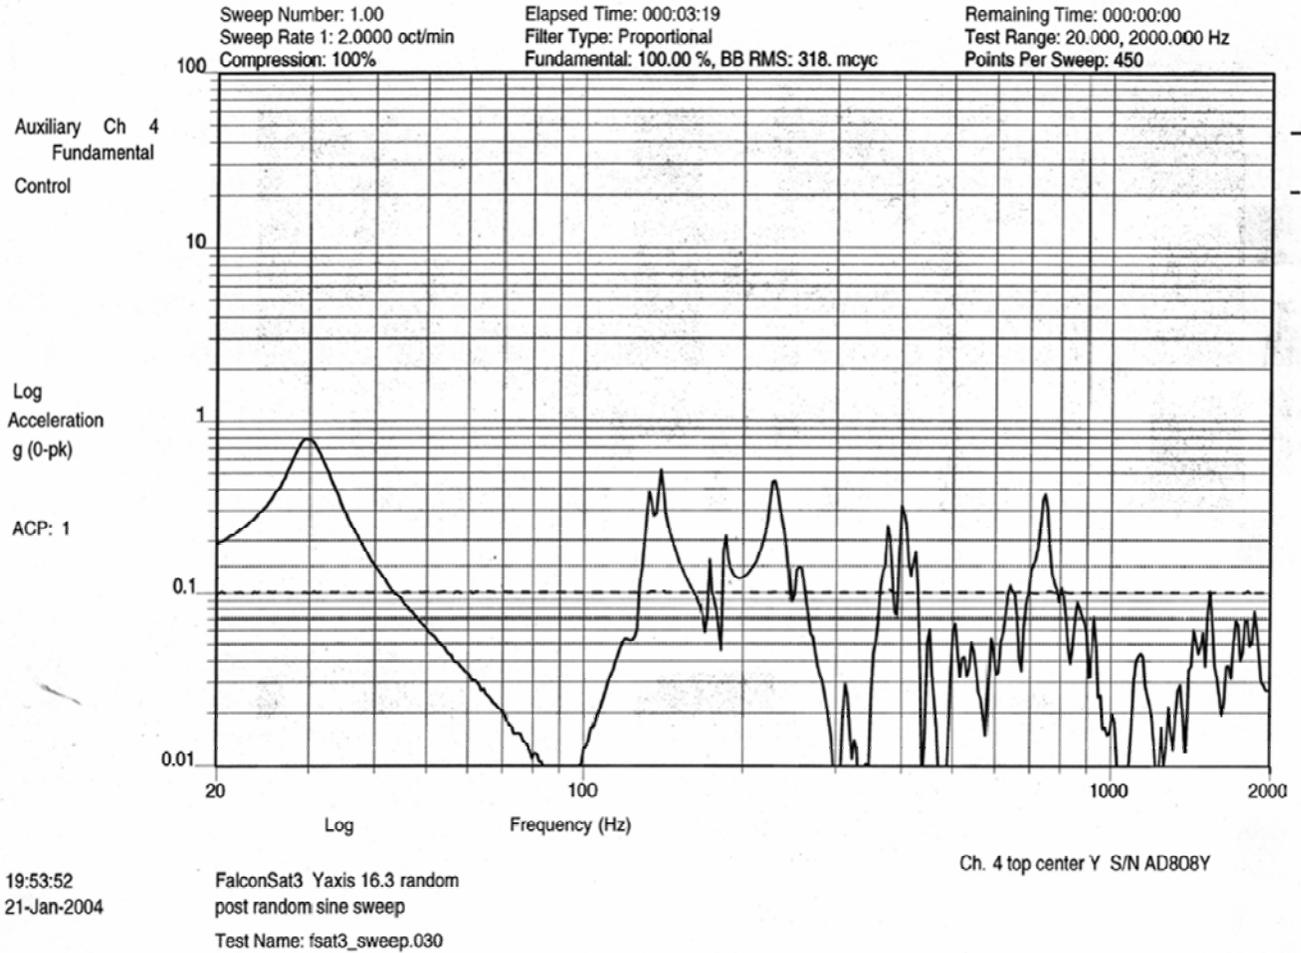
Figure 25: Post Qualification-Level Random Vibe Sine Sweep

Following this random vibration test, a sine sweep was conducted to the levels indicated in Table 14 Sine sweep vibration specification. After a reasonable sample of the bolts were checked for the proper torque it was determined that less than 20% of the torque had been lost on any one bolt. The plot below illustrates the sine sweep results for the top panel following this test. As you can see, the fundamental frequency following this test remained almost unchanged, indicating structural integrity. Plots remain unchanged, for the most part, from one accelerometer to the next.

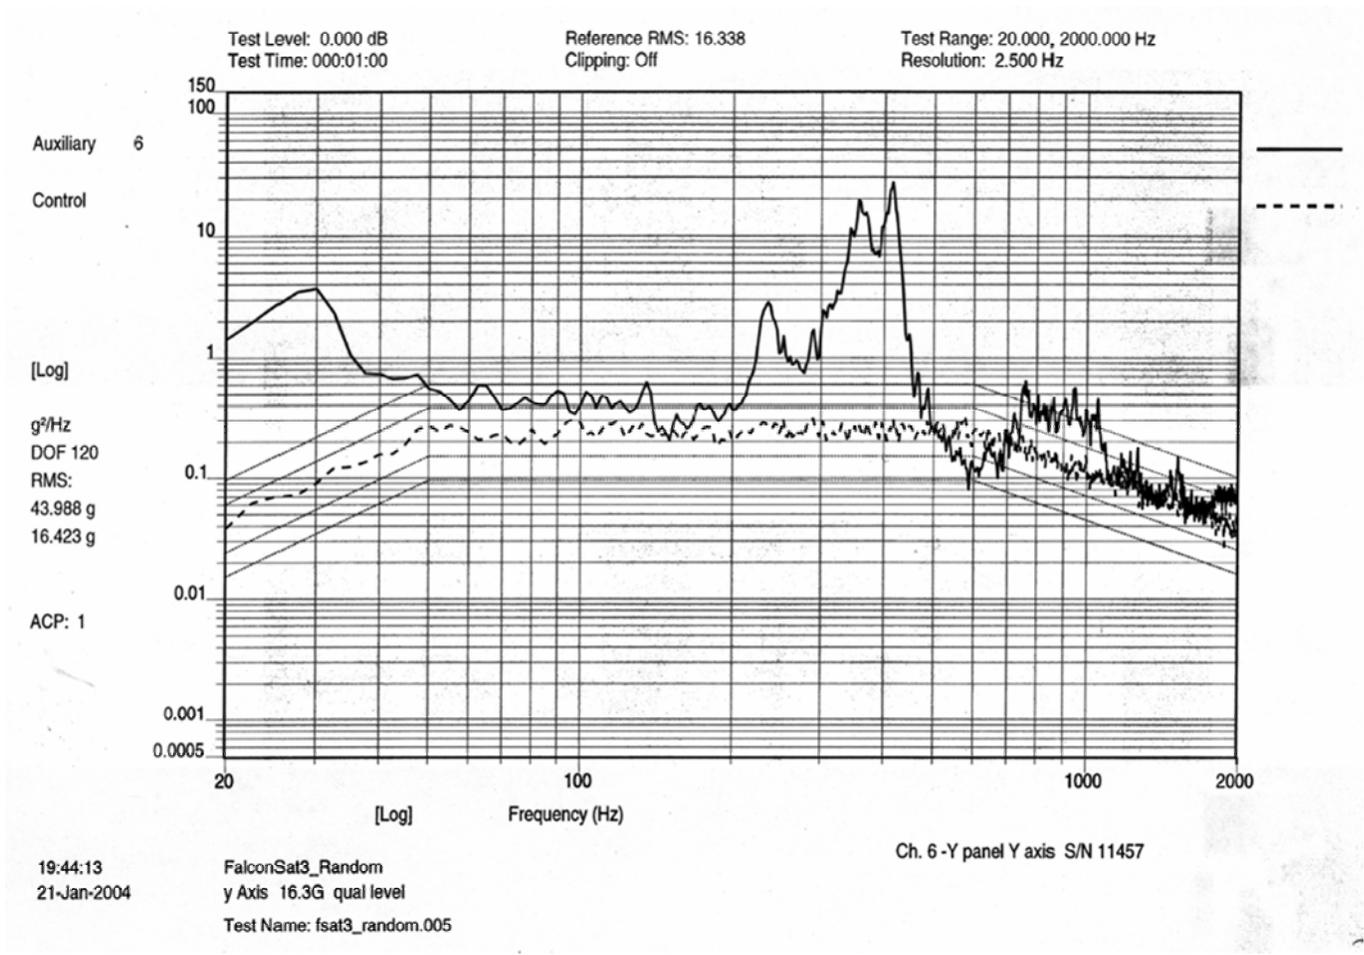
Figure 26: Y Panel Y Axis with Shockring

Several observations were made with the results of the random vibration test. One observation was that on the Y panel, where the solar panel is mounted, there was an amplification in the Y direction from the input of 16 g's to approximately 26 g's at the 450 Hz frequency. This is illustrated in the figure below.

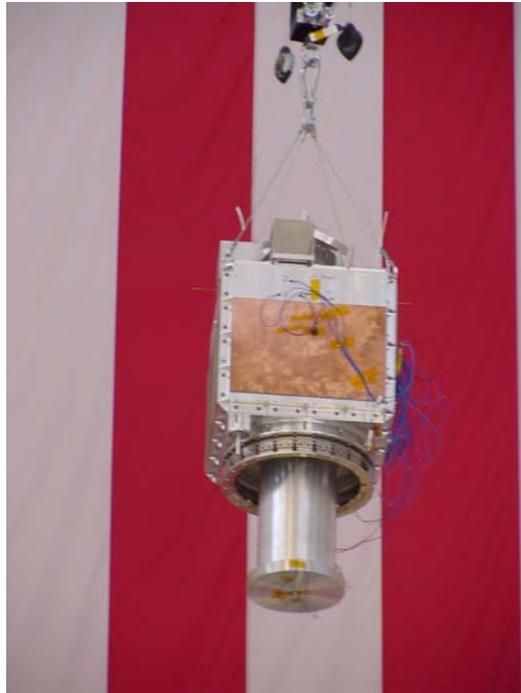
Figure 27: Configuration for +/- Y-axis test article without shockring.

The test article consisted of the SEM-2 without the Shockring, only the lightband attached as shown in Figure 22 along with a spacer ring to represent the shockring.

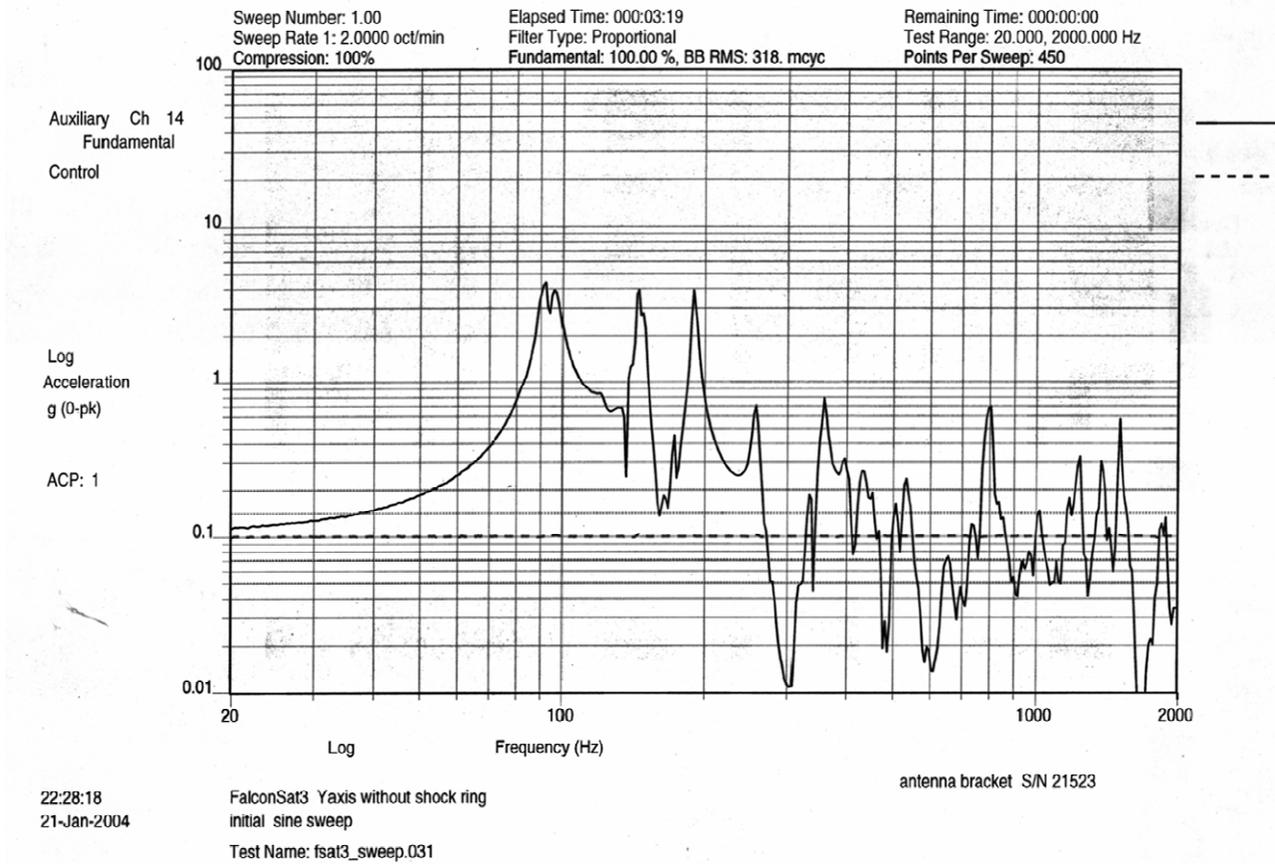
Figure 29: Plot of Antenna Bracket reaction during sine sweep

The sine burst test was run twice. During the first test, it was noticed that the accelerometer on the MPACS was inoperable. The accelerometer was replaced and the test was re-run. Both sets of data were collected, and the first will be used as a reference only if necessary. The location of the first rocking mod occurred at approximately 90 Hz. This is a huge discovery for the FalconSAT 3 SEM-2 as well as the shockring manufacturers. This is approximately 60 Hz higher than that of the test run with the shockring where the first mode was found to be 30 Hz. Fundamentally there was no structural damage to the satellite which allowed us to continue testing without any delays. You can see an example of the output from the satellite in the plot below.

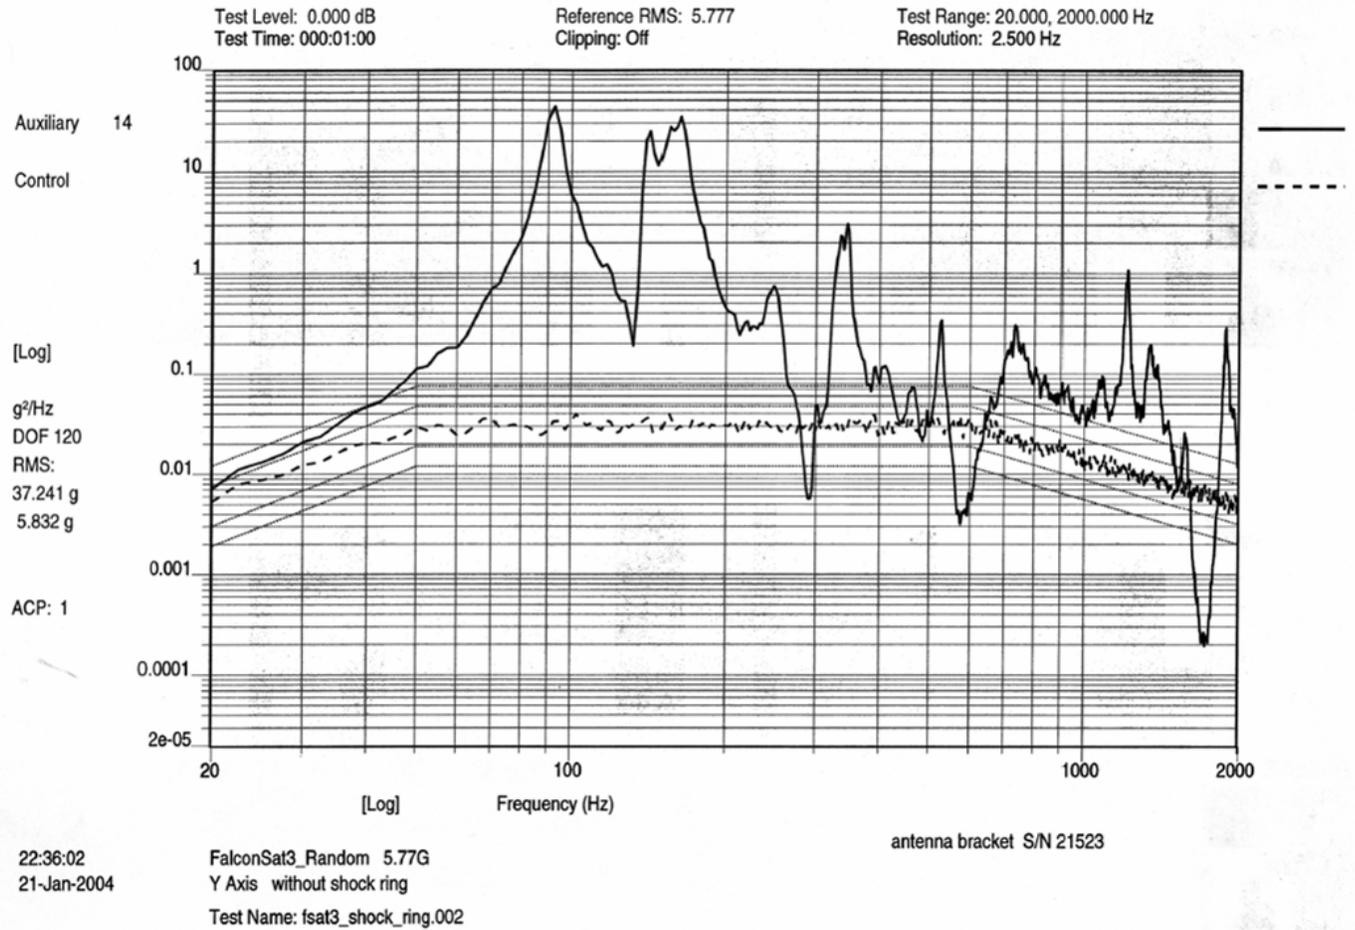
Figure 30: Plot of Antenna bracket response during random vibrate

Some of the most notable results came from the structure of the satellite. The first being the antenna bracket on top of the structure. The bracket saw a great deal of vibration as seen in the plot below.

In the plot you can see that the bracket reached amplification on the order of 300 g's rms around the first mode that was found to be at 90 Hz. This could prove difficult with many delicate sensors that are to be attached to the bracket. The other section of the satellite that showed notable results was the boom tip. Its results can be seen below.

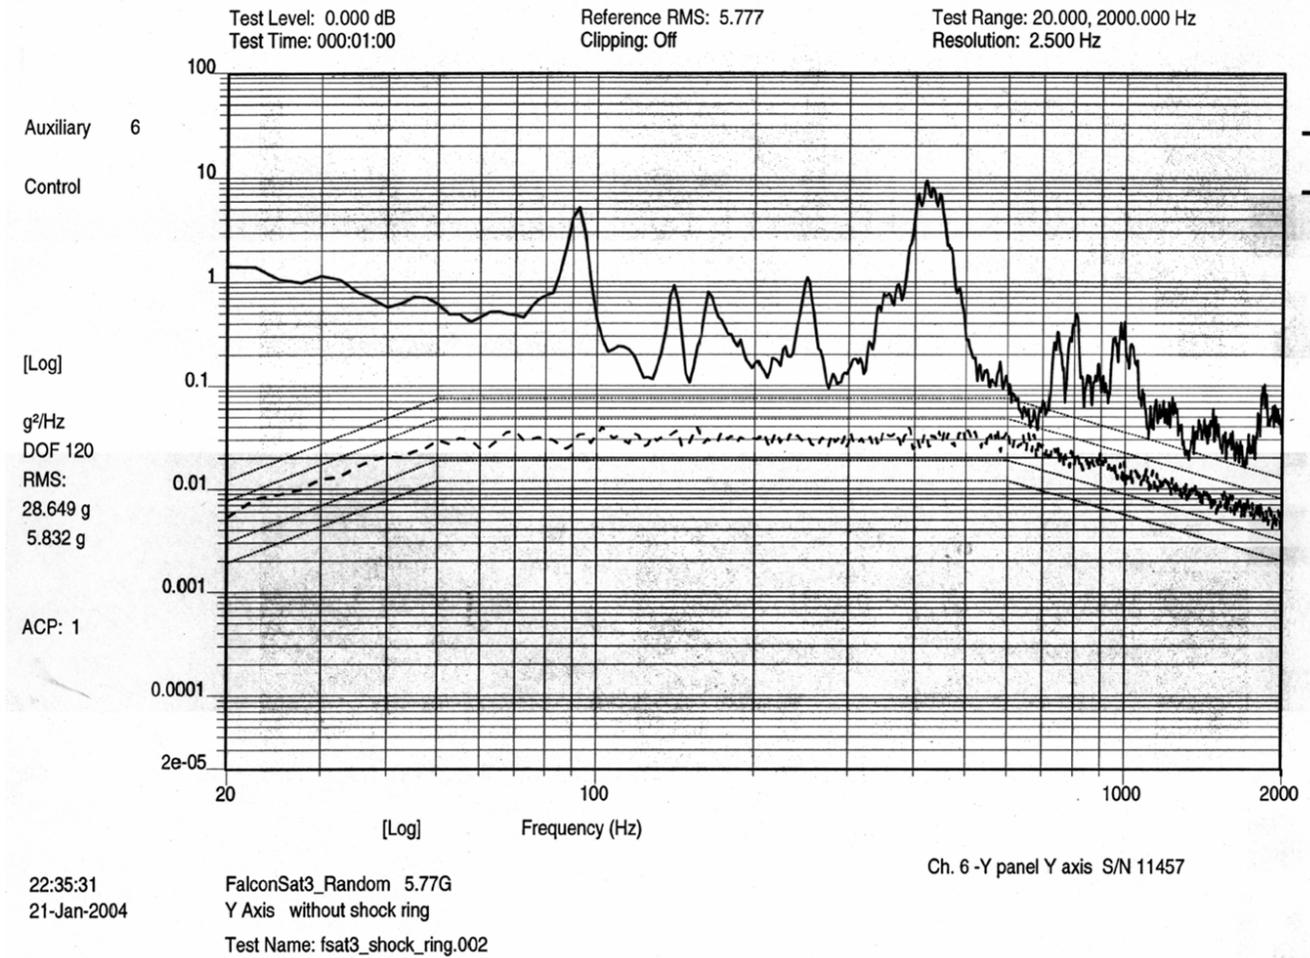
Figure 32: Plot of the random vbe response on the -Y panel

In th general there were some common results from the random vibe throughout the satellite. At higher frequency great deals of amplification was found. This can be seen in the following plot of the Y panel towards the higher frequencies on the plots.

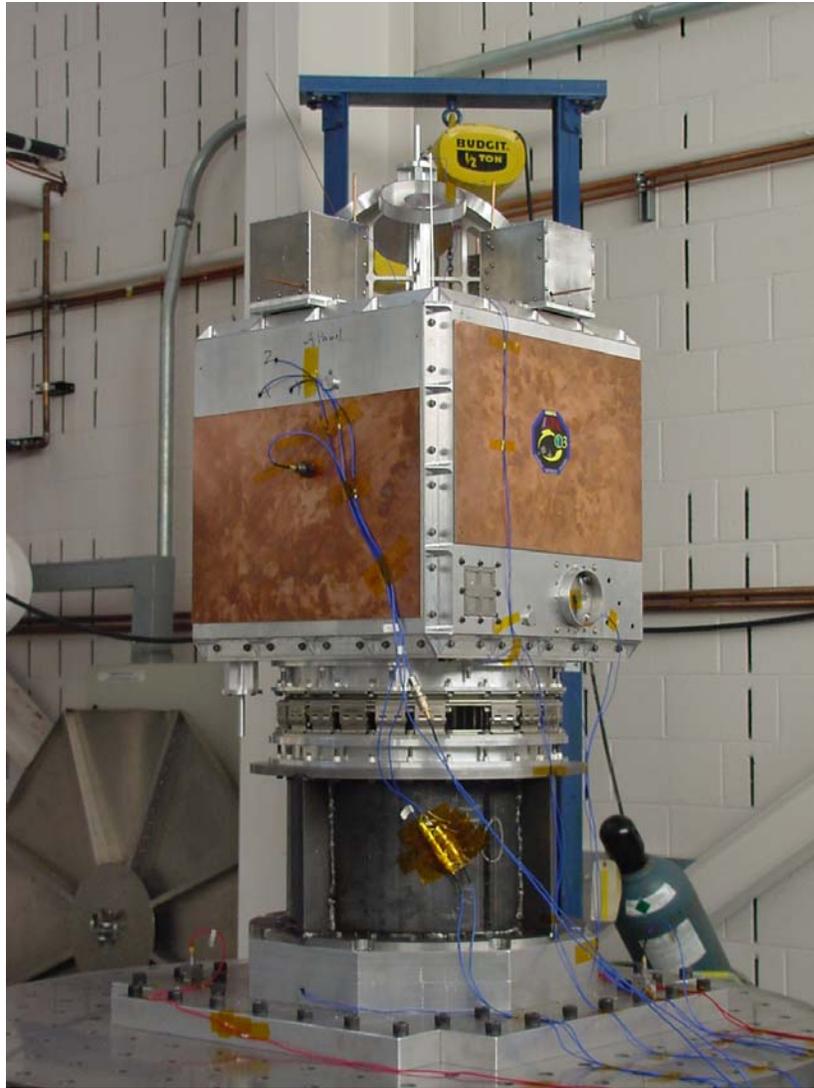
Figure 34: Configuration for +/- Z-axis test article without shockring.

The test article consisted of the SEM-2 without the Shockring, only the lightband attached as shown in Figure 33 along with a spacer ring to represent the shockring.

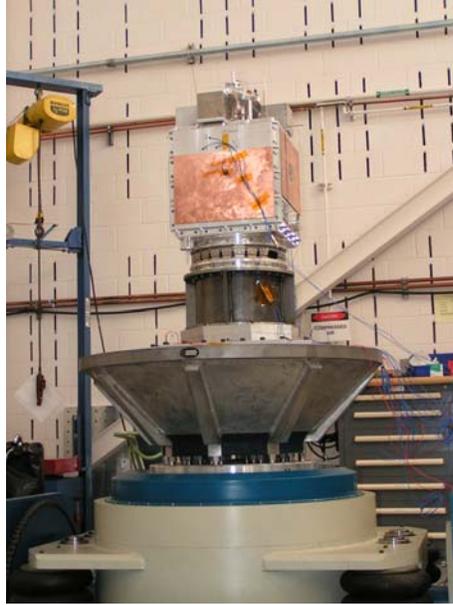
Figure 36: Configuration for +/- Z-axis test without Shockring attached to the test table.

The SEM-2 was bolted to the FalconSAT-3 test fixture. The test fixture was bolted to the table in the same configuration as described in Section 5. The test configuration is shown in Figure 35.
