Falcon Sat-3

2nd Structural Engineering Model (SEM2)

Vibration Test and Mass Properties Measurement

Test Report

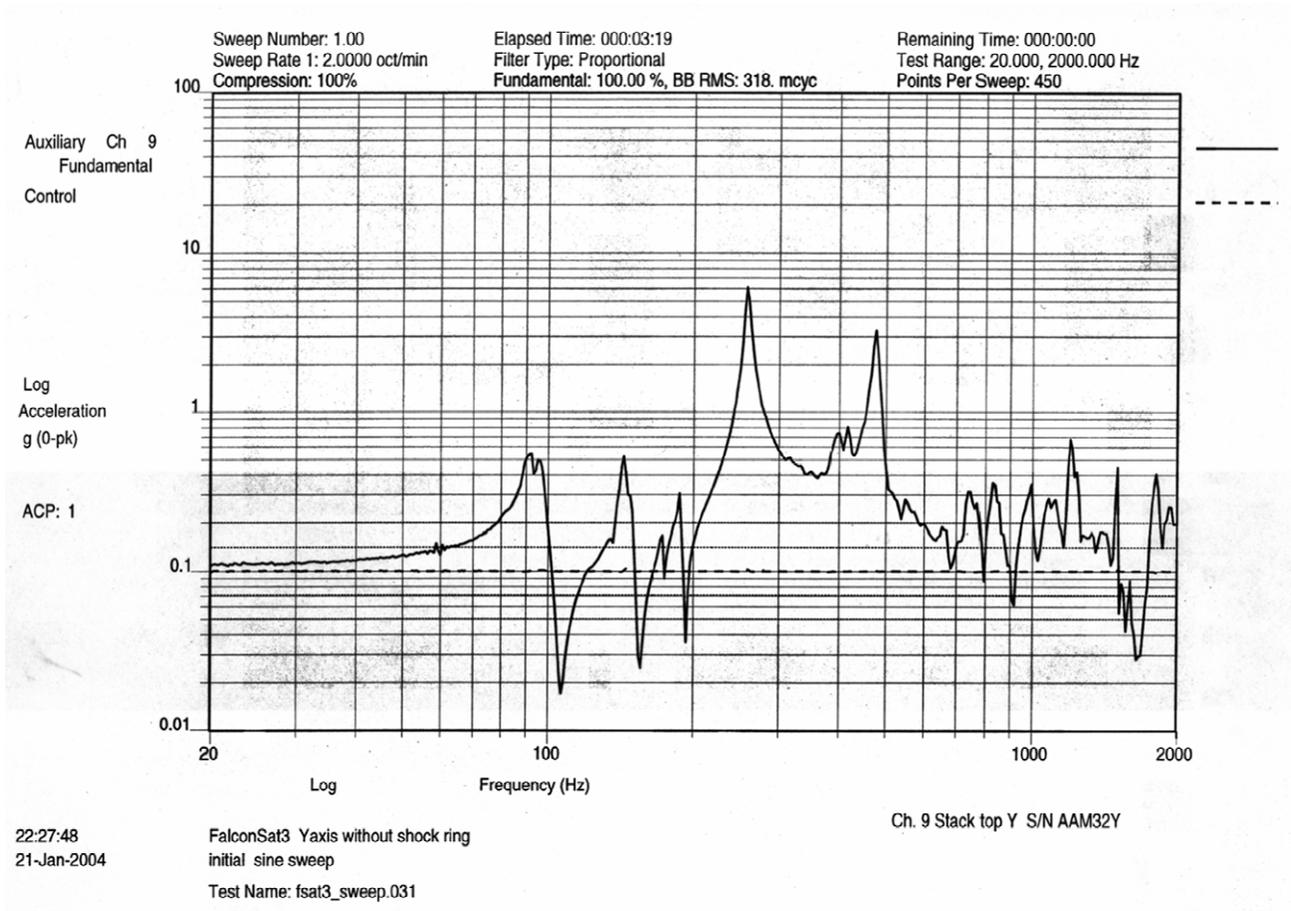
Figure 37: Stack top initial sine sweep

The sine sweep came out much as predicted. The fundamental mode was found to be 170 Hz. This is no where near the predicted number due to the fact that the predicted number was based off of the Y axis testing. The results from the Z axis testing can be seen below.

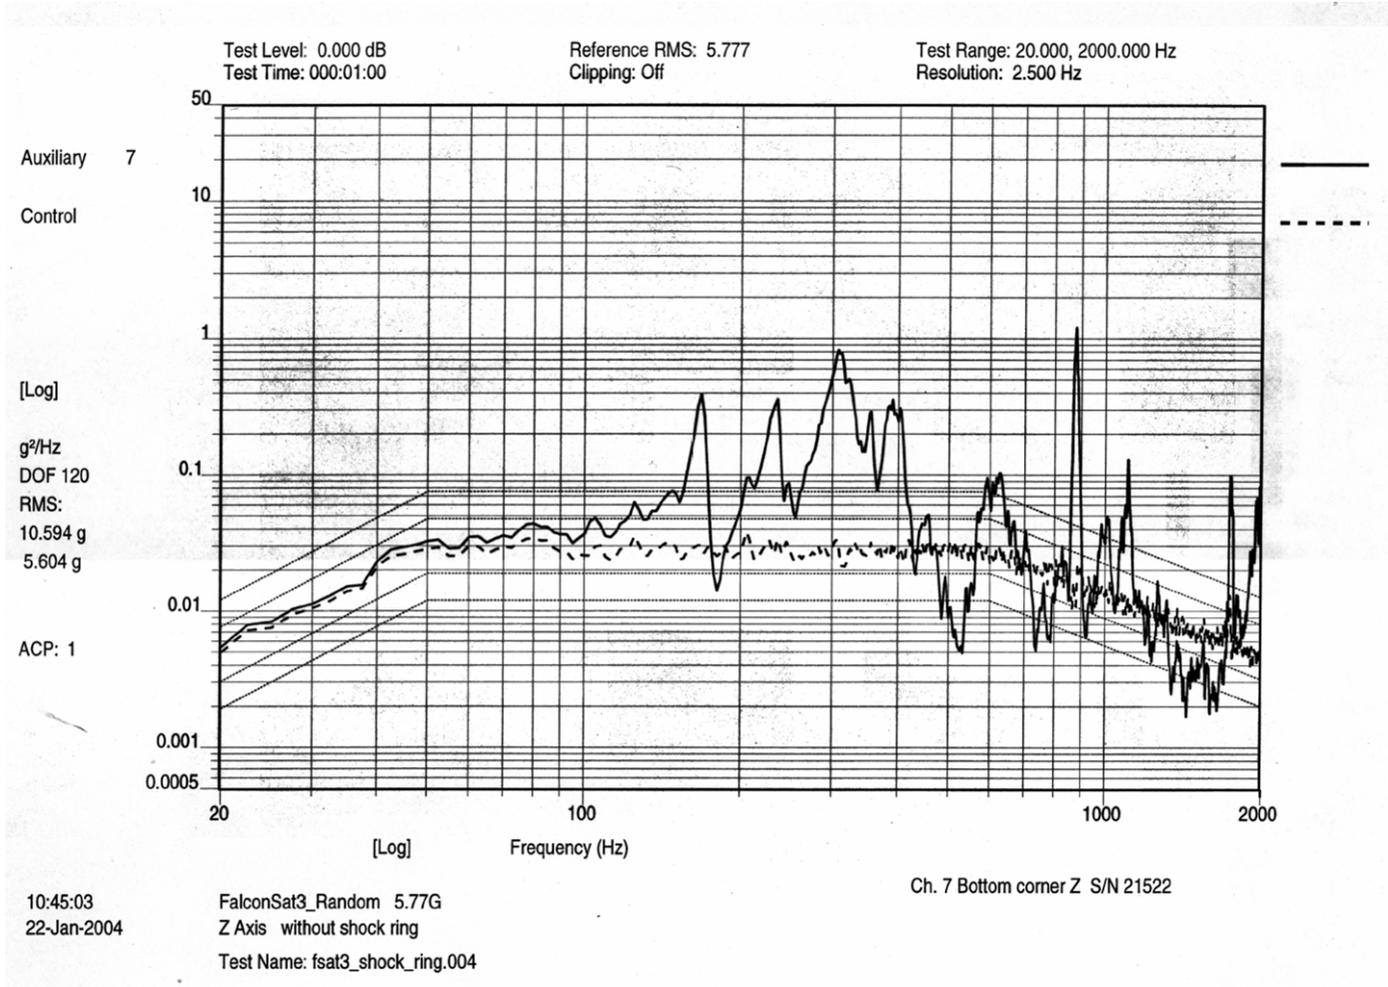
Figure 38: Random vibrate test of the Bottom Corner Z axis

As seen in the plot above there were no extremes to the Z axis. In general this test brought about very few shocking results that should be taken note of. The following plots illustrates some of the other responses to the random vibrate at flight levels.

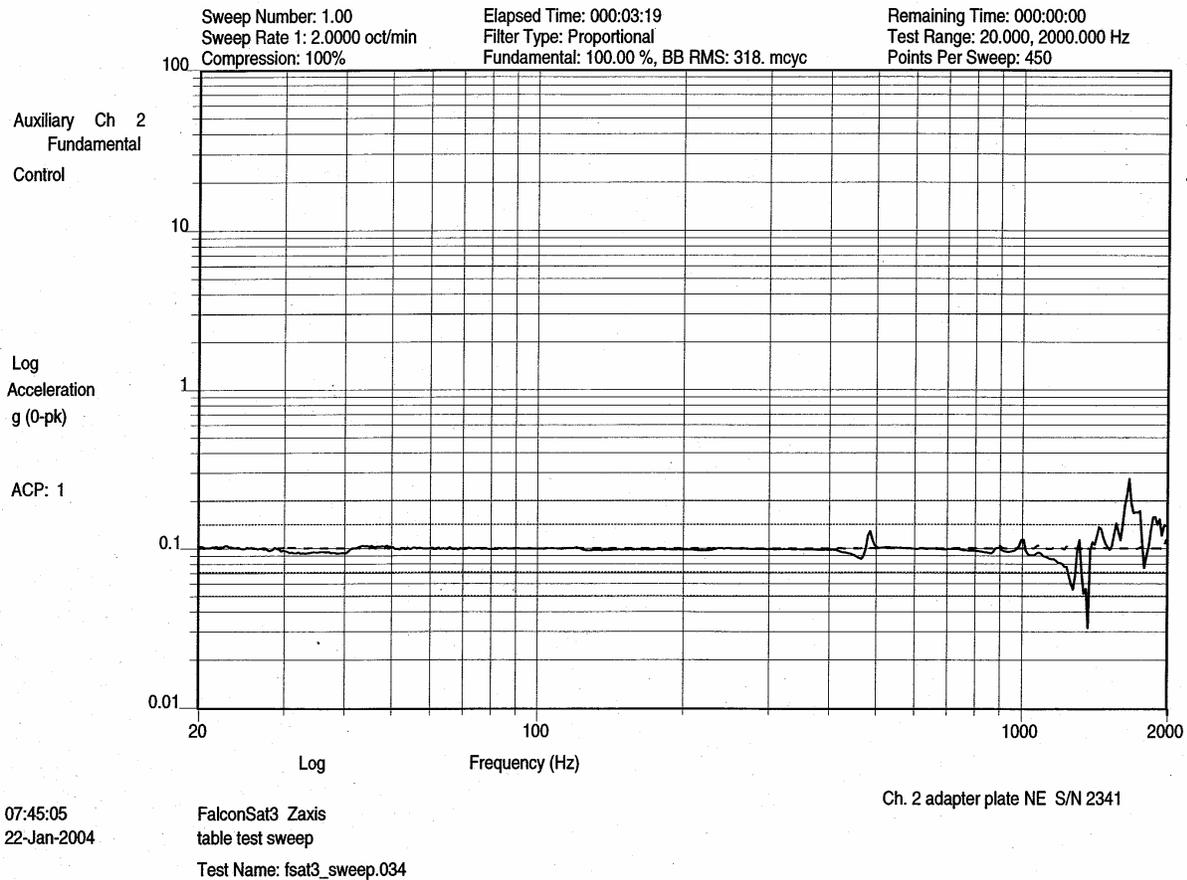
Figure 42: FalconSat3_Zaxis Initial Sine Sweep Table Test (Auxiliary 3).

Once the vibration table was returned to service, the sine sweep was repeated. Results from the top of the fixture indicated the first mode natural frequency of the test fixture was ~800 Hz as shown in

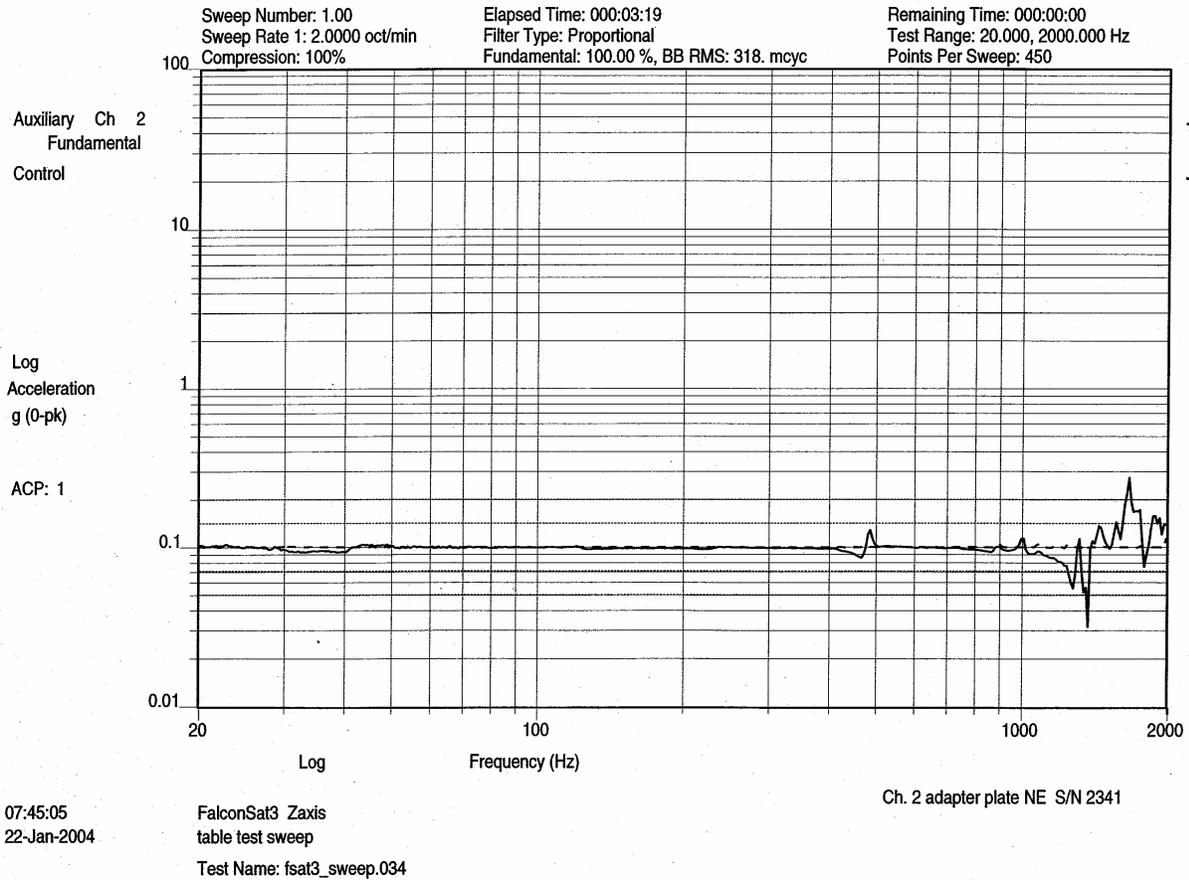
Figure 44: Test Fixture Sine Burst.

The sine burst test was run on the test fixture in order to fully characterize the test fixture before the satellite was added. There was no sine sweep to follow the sine burst test due to the fact that no failure was observed in the test fixture nor is it at all likely that the extremely durable test fixture had any failure or change in its structure.

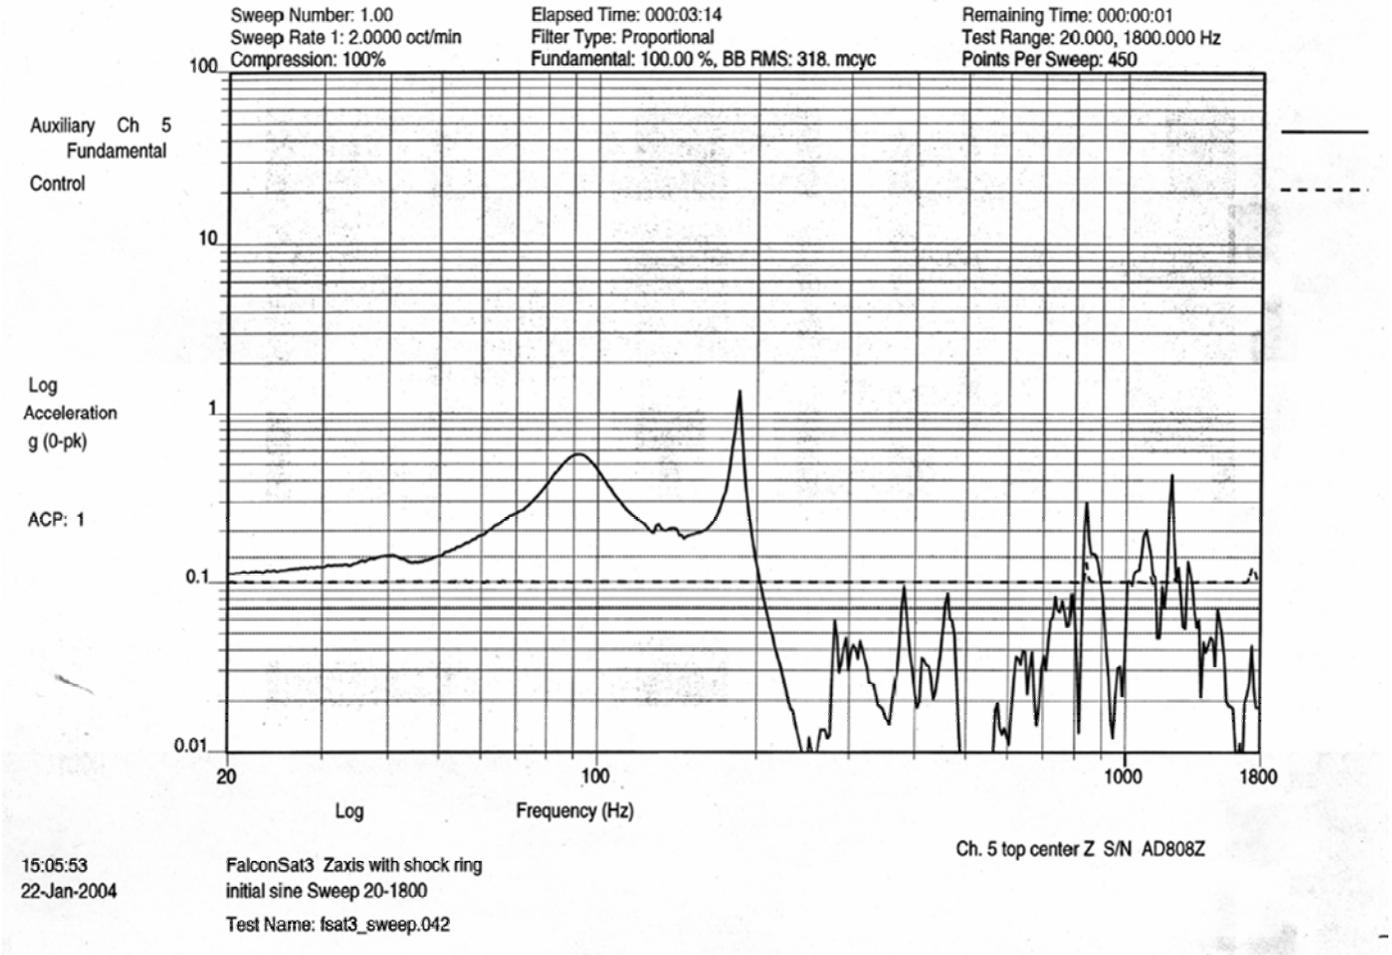
Figure 46: Initial Sine Sweep +/- Z

These frequencies are illustrated in the following figure which depicts the initial sine sweep response of the top panel with the shockring.

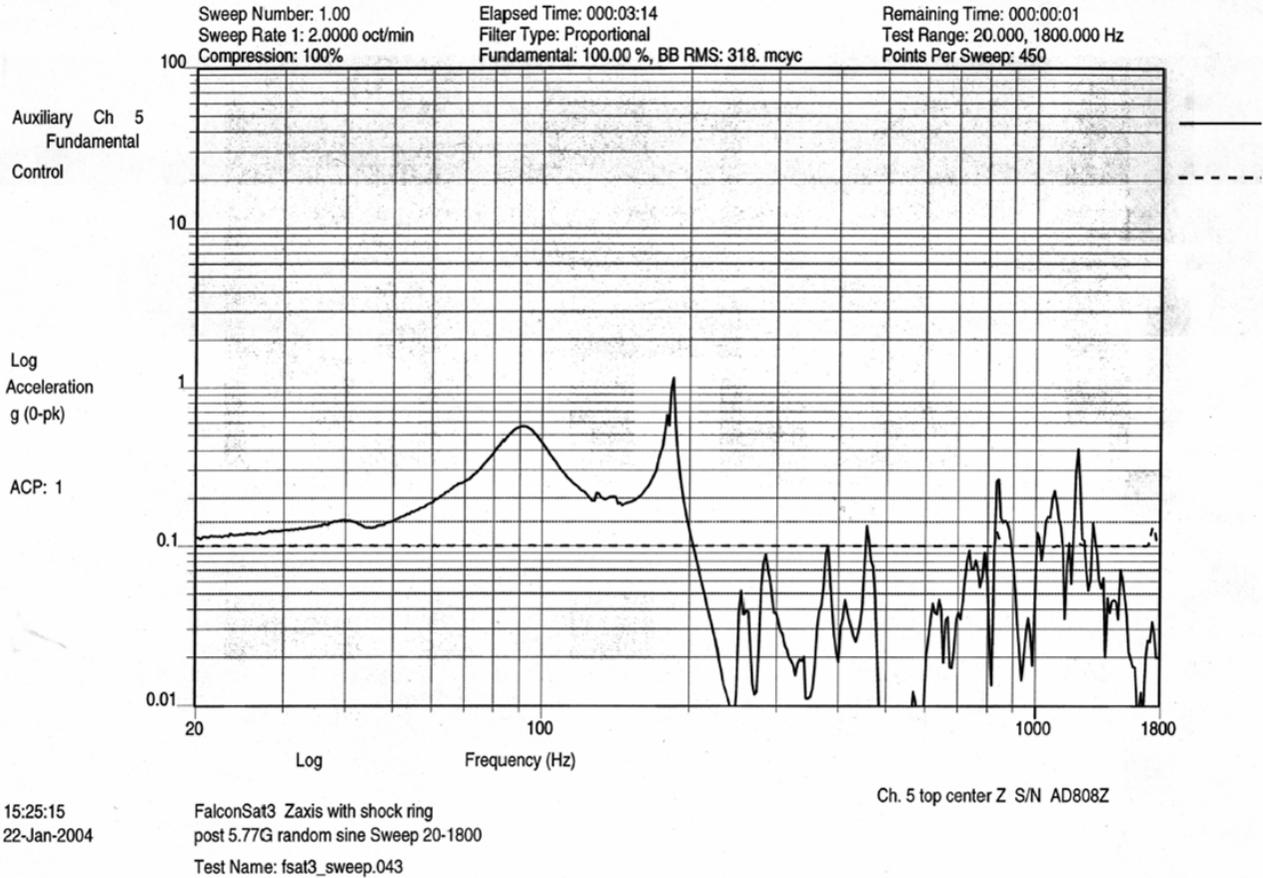
Figure 47: Post Characterization-Level Random Vibe Sine Sweep

Following this random vibration test, a swine sweep was conducted to the levels indicated in Table 36 Sine sweep vibration specification. After a reasonable sample of the bolts were checked for the proper torque it was determined that less than 20% of the torque had been lost on any one bolt. The plot below illustrates the sine sweep results for the top panel following this test. As you can see, the fundamental frequency following this test remained almost unchanged. Plots remain unchanged, for the most part, from one accelerometer to the next. Another notable response is the high cross axis response at the 840 Hz on the center of the top panel up 10.3 g rms.

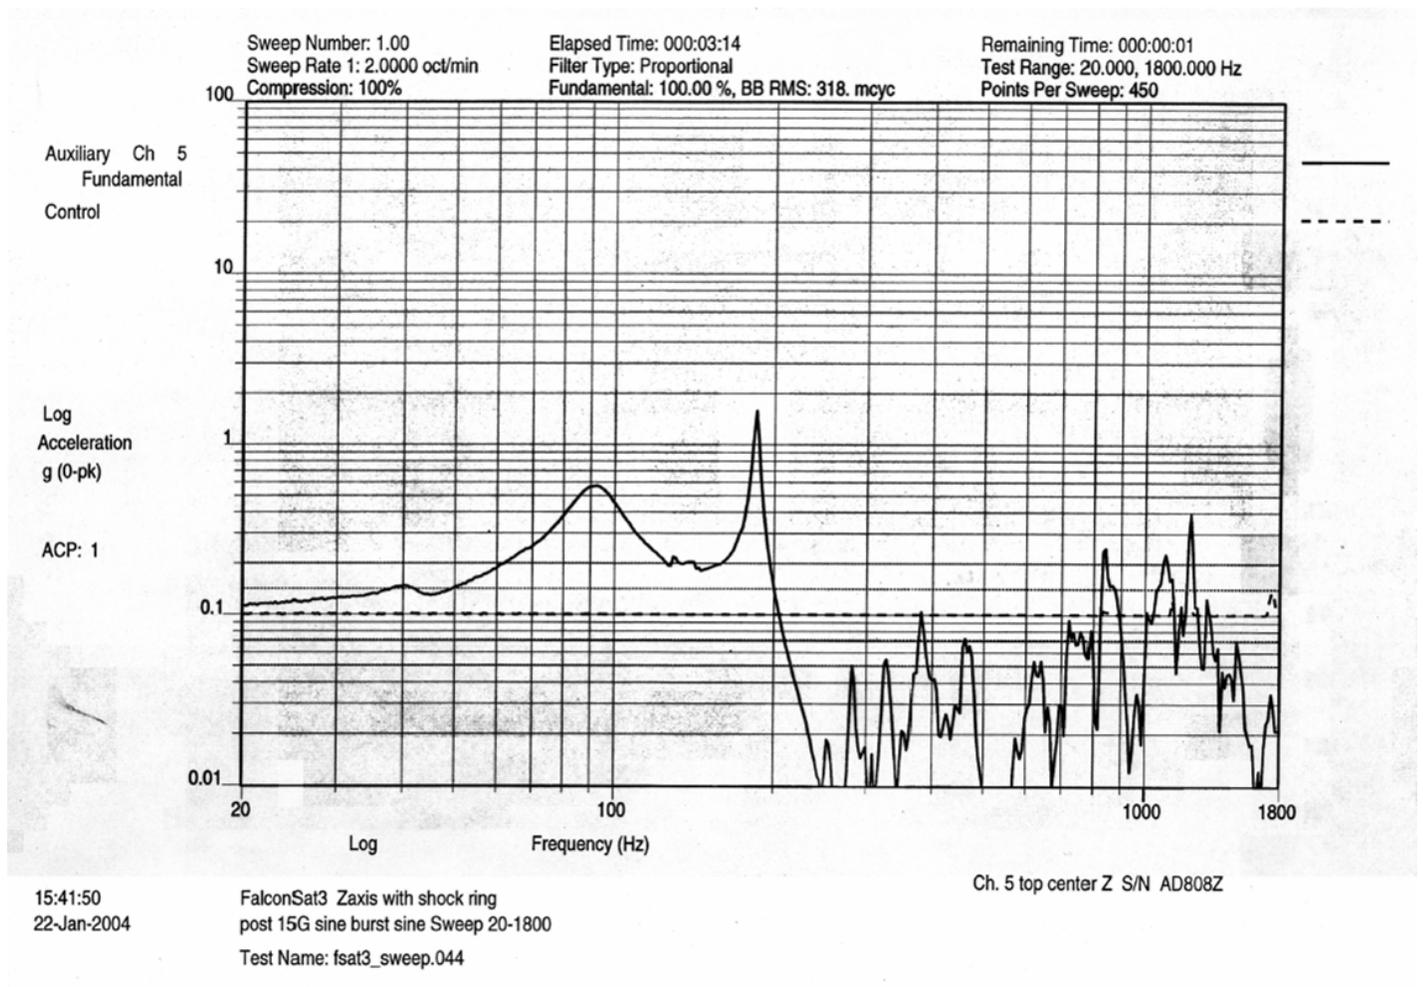
Figure 48: Post Sine Burst Sine Sweep

Following this series of sine bursts, a swine sweep was conducted to the levels indicated in Table 36 Sine sweep vibration specification. After a reasonable sample of the bolts were checked for the proper torque it was determined that less than 20% of the torque had been lost on any one bolt. The plot below illustrates the sine sweep results for the top panel following this test. As you can see, the fundamental frequency following this test remained almost unchanged. Plots remain unchanged, for the most part, from one accelerometer to the next.

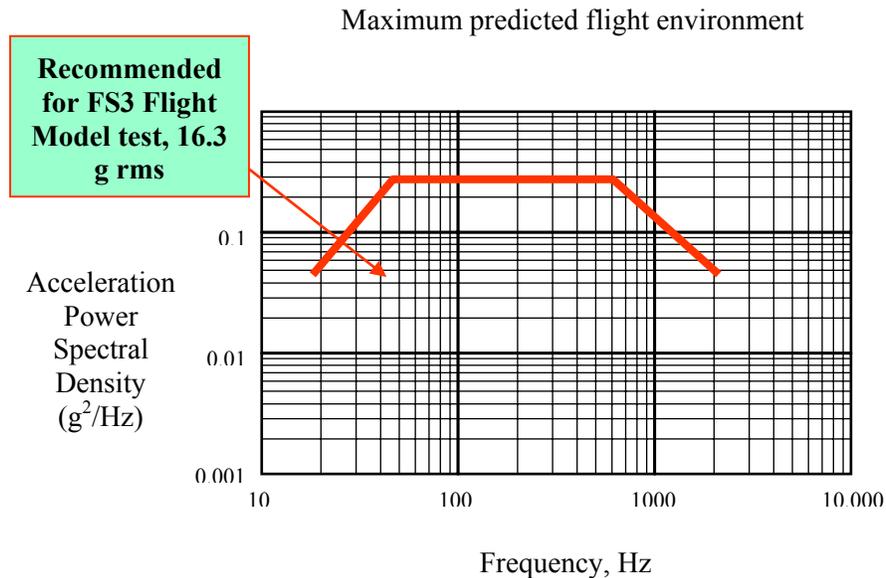
Figure 49: FalconSAT-3 Qualification-Level power spectral density.

Random vibration qualification levels are shown in Table 41 FS-3 Qualification Random Vibration Level and Figure 49: FalconSAT-3 Qualification-Level power spectral density.. These represent +6dB above the flight level. Based on recommendation from CSA, the duration was increased to a full 2 minutes.

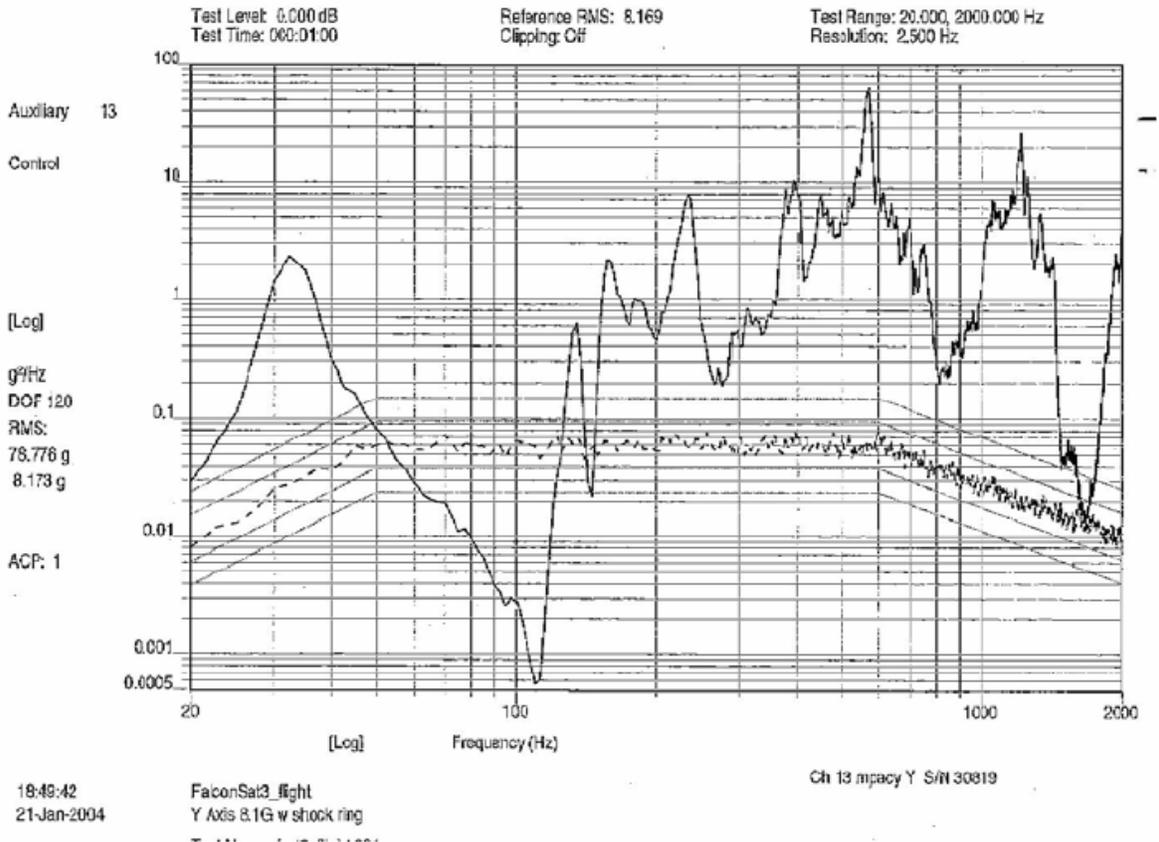
Figure 50: MPACS Response (note 400 Hz response that comes from accelerometer placement)

The levels reached in the below figure were resultant of the accelerometer being mounted to a thin piece of metal on the inside of the MPACs instead of a piece of metal on the outside of the accelerometer which would be more representative of the experiments actual response.

There were other parts of the structure that showed interesting responses throughout the tests. The stack showed a module response as a whole that was polluted by a failure inside of the entire system. For this reason Mr. Serafin recommends that we ignore the peak at the 240 Hz mark. The MPACS response was also skewed by the same occurrence. The peaks at 400 Hz PSD need to be ignored due to system failure. The MPACs themselves as a unit will not vibrate on such a high level.
